**Subject: Clutch Master Cylinder**

**Application: All 9000 Models**

<b>CATEGORY</b>	
<b>Transmission</b>	
<b>SECTION</b>	<b>PAGE</b>
4	12
<b>ISSUE</b>	<b>CODE</b>
05/93-0329	412

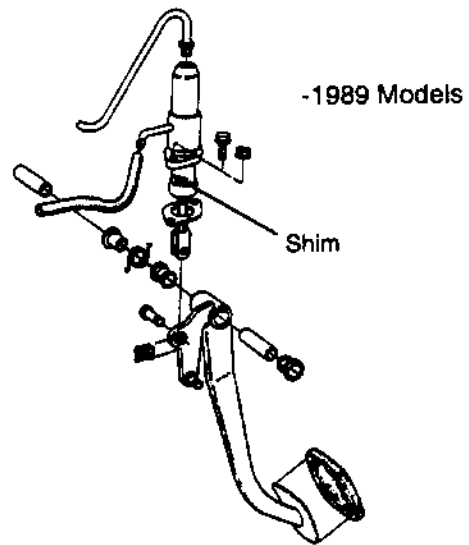
**Figure 1. Master Cylinder Replacement – 1989 and earlier.**

The return port in the master cylinder may be blocked off due to a swollen seal. This will cause a pressure build up in the system, and result in one or more of the following complaints:

- Smooth rubber supply hose emits a plasticizer similar to mineral oil, which causes the seal to swell
- Seal swells due to effects of heat
- Mineral oil may have been added to reservoir, contaminating system.

On -M89 cars (Figure 1), it is important to ensure that the cylinder is fitted straight relative to the pushrod. If the cylinder is not in alignment with the pushrod, adjust it by placing a 1 mm shim between the front mounting lug and the bulkhead. Make sure that the cylinder is sealed against the bulkhead panel after adjustment.
