**Subject: Customer Satisfaction Campaign 428:
Top Mechanism Quality Improvement**

Application: All 1995 900 Convertibles

CATEGORY Body	
SECTION 8	PAGE 149
ISSUE 04/97-0754	CODE 812

PSI 04/97-0754

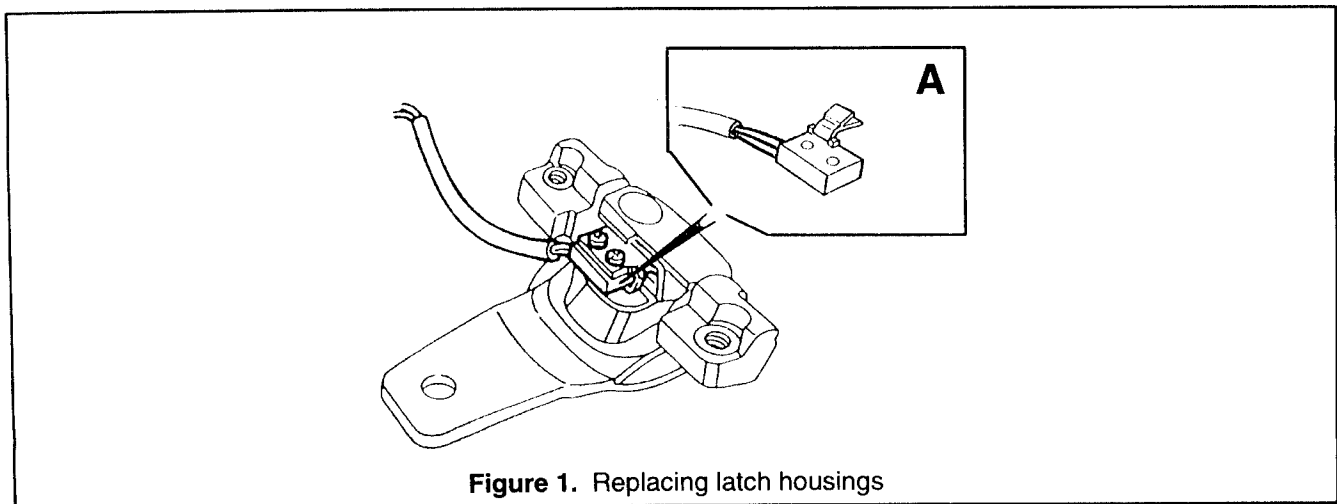
Figure 1. Replacing latch housings

Deformation of the latch housings in the windshield frame by the first bow's guide pins may sometimes occur, resulting in the lever arm on the microswitch not having enough room to move. The housing should be replaced. The new parts have been modified to relieve excess material in this area. Also note that within certain VIN Serial No. ranges the microswitches may also have to be replaced.

Check that the microswitches have been changed and that the microswitches, P/N 46 95 979 (Figure 1, point A) are fitted as described in PSI 04/97-0753. Also check that the lever arm on the microswitch has not been damaged by this interference. If the microswitch is damaged, replace it.

1. Change the latch housings. See "Removal and Fitting" on page 244 in Service Manual 8:5 Cabriolet.

Tightening torque: 157in.lbs. (18Nm)

2. If the microswitches (Figure 1, point A) are undamaged, transfer them to the new housing.

If the vehicles is within VIN Serial No. range S7000216-S7016595, change them if they have not yet been replaced.

Tightening torque: Max. 8.88in.lbs. (1Nm). Do NOT overtorque. Overtightening can affect switch function.

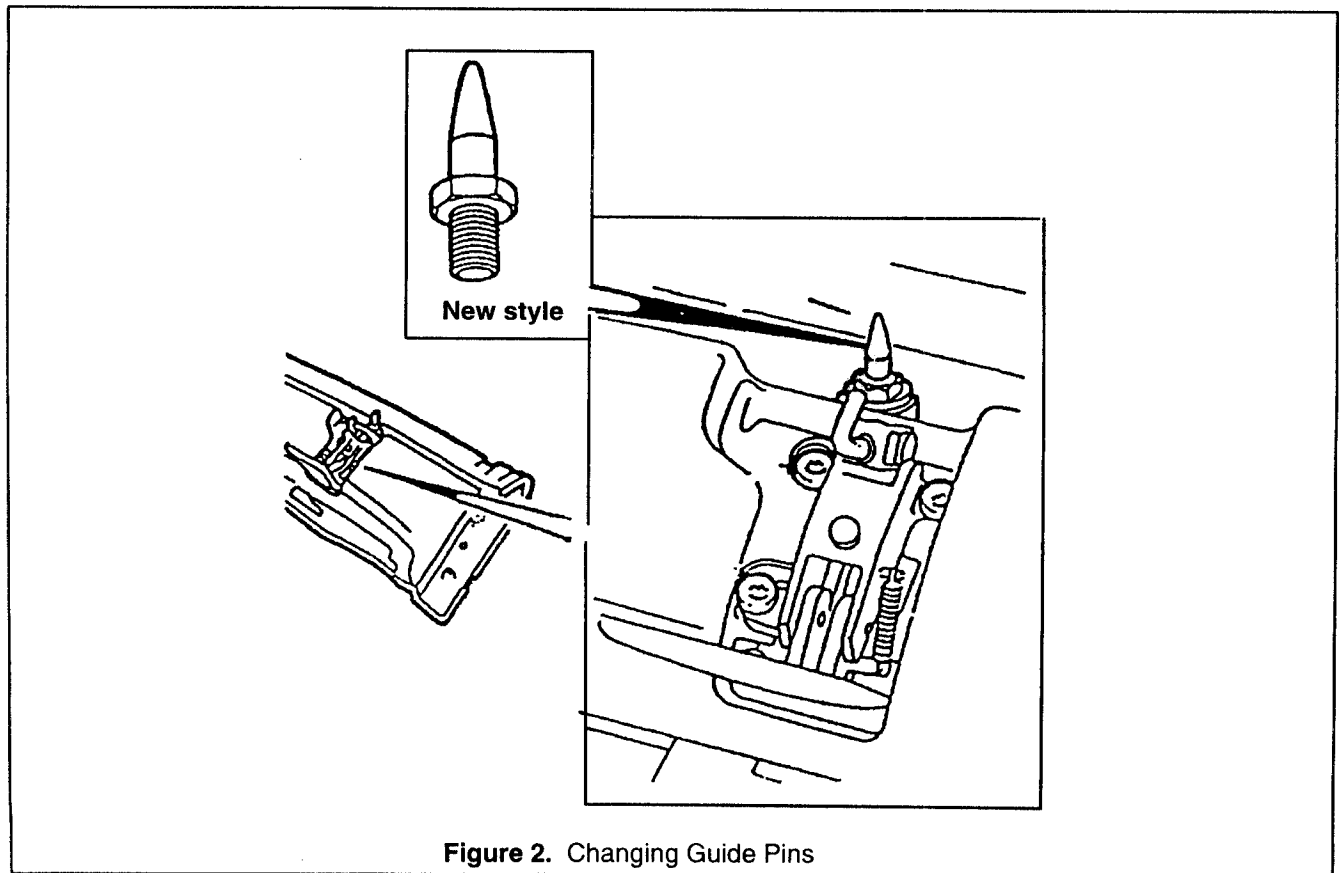
Figure 2. Changing Guide Pins

In some cars, compression of the header seal is insufficient (the guide pins are too long and bottom in the microswitch housings). For this reason, a shorter guide pin has been developed.

Change to guide pin P/N 47 66 895.

Since the guide pin on the right-hand side is adjustable, mark its position before removing it.

Adjust top stops as described in Service Manual 8:5 Cabriolet, page 130.

If necessary, also adjust the J-hooks as described on page 132 of Service Manual 8:5. Check the up stop height and adjust as necessary. Reprogram.

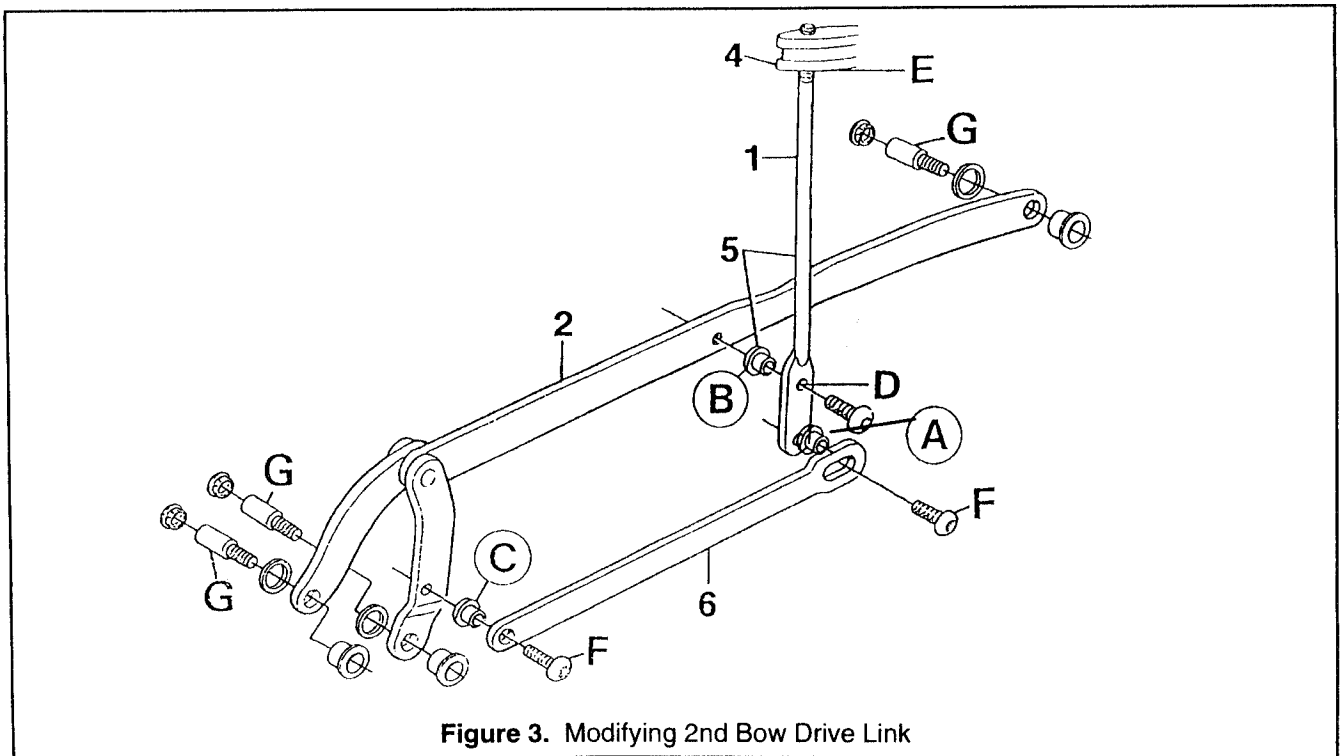
Figure 3. Modifying 2nd Bow Drive Link

On some cars the second bow may not retract correctly when the top is lowered, resulting in deformation of components in the top mechanism. To counteract this, a mechanical actuating linkage system for the second bow has been introduced on the left-hand side. **Also be sure to see Step 4 in PSI 04/97-0753.**

1. Remove the screw securing the threaded rod to the intermediate link. Measure the distance between the center of screw hole D (see Figure) and the bottom edge E of the second bow (see Figure 3). Make a note of this distance and remove the threaded rod.
2. Remove the intermediate link.

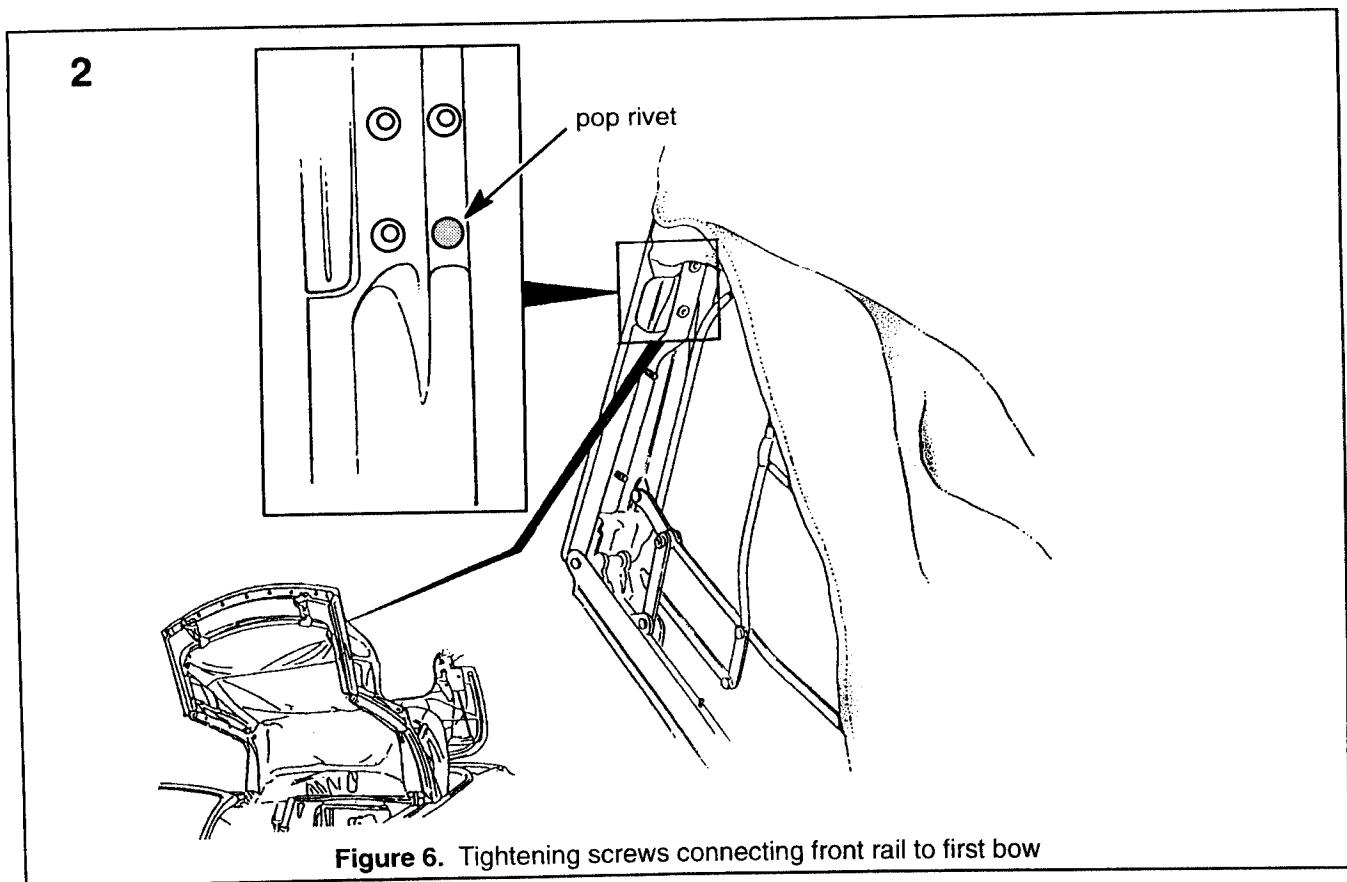
On some cars the screws between the front rail and first bow may work loose, resulting in noise and excessive free play.

1. Operate the top by means of the ROOF switch until it is halfway open at the same time as the Tonneau cover is in the vertical position. The door windows and side windows should be lowered.
2. Lift up the top cover to expose the screws.
3. Remove one screw at a time and apply thread locking adhesive, P/N 74 96 268 (or Loctite 242 Blue) to each screw.
4. Tighten the screws.

Tightening torque: 88.8in.lbs. (10Nm)

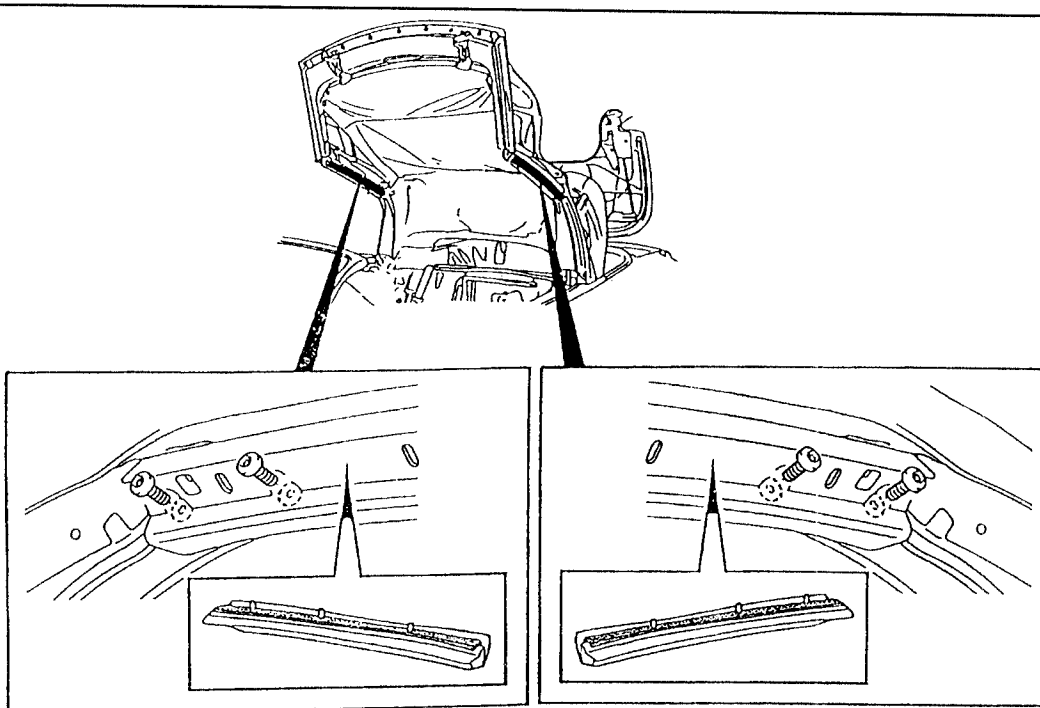
Figure 7. Tightening screws in balance link extension

On some cars the screws for the balance link's extension may work loose, resulting in unwanted noise and excessive free play. This can also cause the guide pins to fall short of the latch housing. Thread locking adhesive should be applied to these screws before they are tightened.

1. Operate the top by means of the ROOF switch until it is halfway open at the same time as the Tonneau cover is in the vertical position. The door windows and side windows should be lowered.
2. Before removal is started, the positions of the dome nuts securing the side rail seals should be marked so that they can be refitted in the same places. See Figure 7.
3. Remove the middle rail's seal retainer with seal. Gently work it loose until it comes away from the rail, being careful to avoid damaging the underlying tape. If the tape is damaged upon removal, it should be replaced.

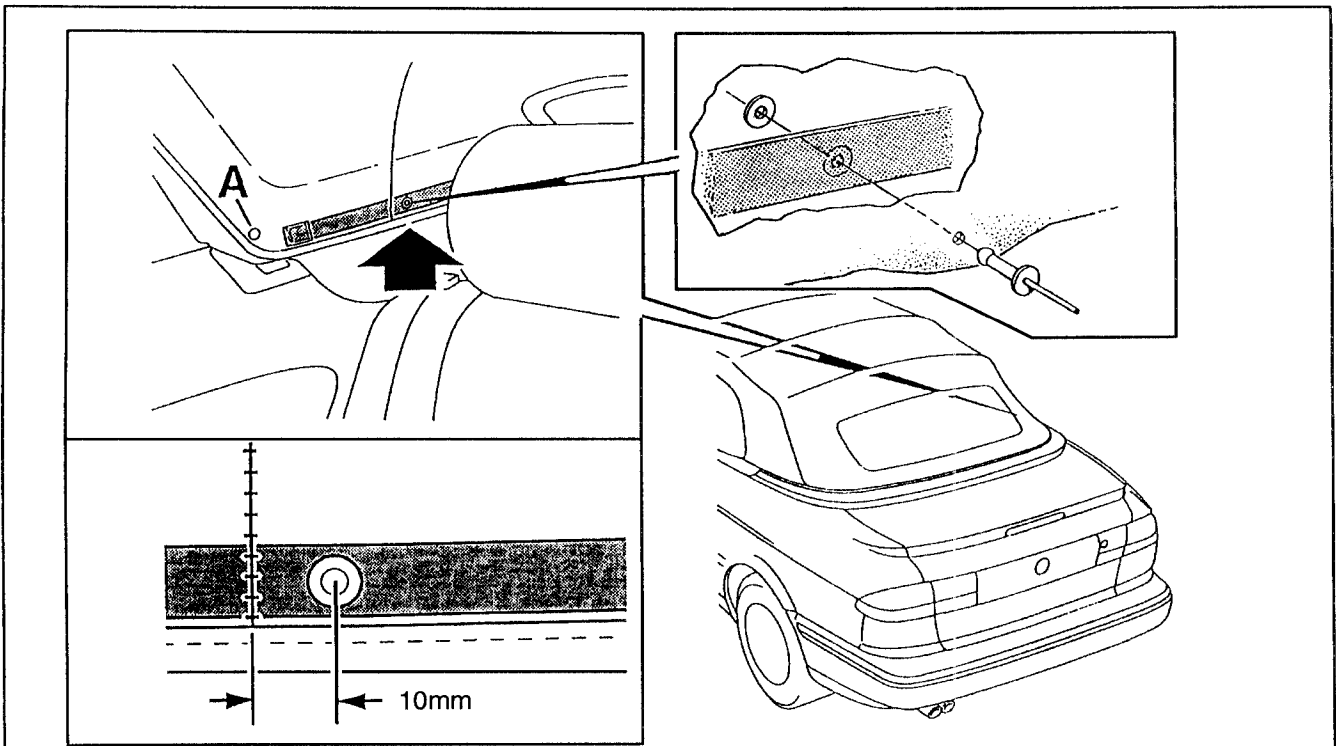
Figure 9. Riveting Elastic Strap

On some cars, the headliner fabric may catch on the upper bolts of the rear seat belts, beside the head restraints, when the top is lowered. To avoid this, the headliner fabric and the elastic strap should be riveted together so that folding of the headliner is improved.

1. Raise (close) the top fully and lower the seat backrest.
2. Check whether the headliner fabric has come loose at rivet A (see Figure 9 on following page). If it has come loose, fit a new rivet, P/N 82 35 178.

5. Using a pair of punch pliers or an awl, make a hole about 5/32" (4mm) in diameter through the headliner and elastic strap about 3/8" (10mm) behind the headliner seam. Make sure that the hole comes in the middle of the elastic strap. See Figure 9 on the following page.

6. Join the elastic strap and headliner together by means of a pop rivet, not forgetting washer, P/N 45 55 975. The pop rivet should be fitted with the black head facing the inside of the car.

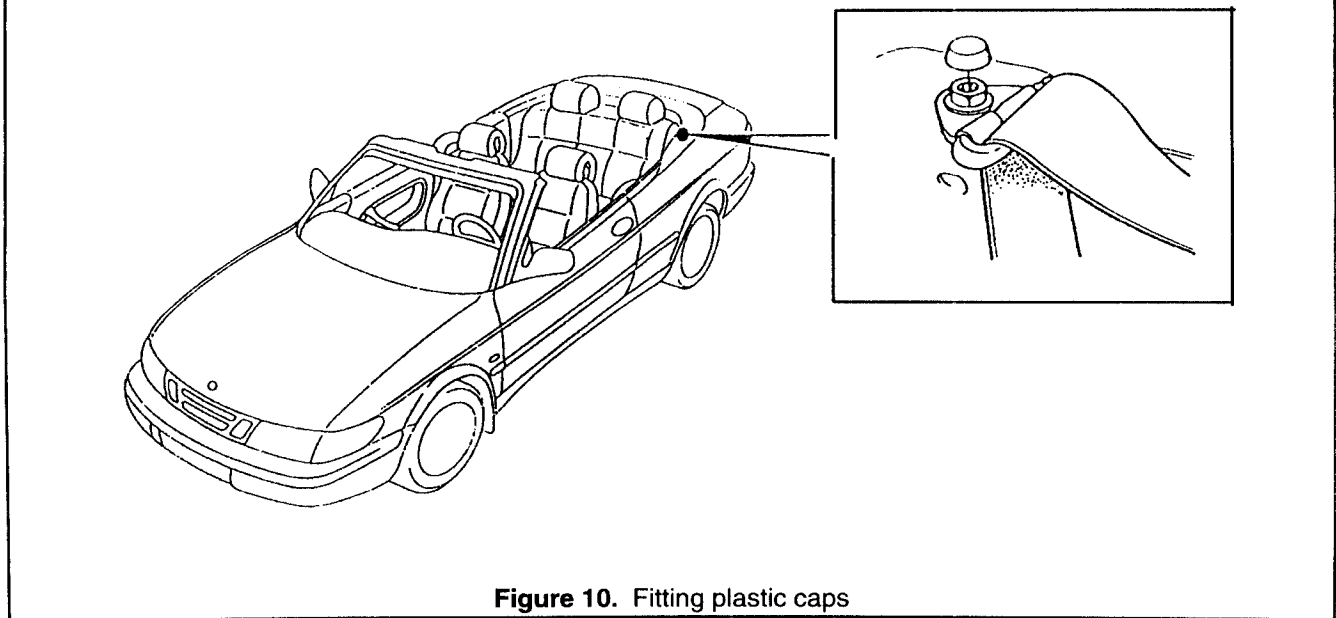
Figure 10. Fitting plastic caps

To further minimize the risk of the headliner catching in the bolts of the rear seat belts, the bolt heads on cars up to and including VIN Serial No. S7011443 should be fitted with a trim cap.

7. Check the riveted joints.
8. On cars having VIN Serial No. up to and including S7011443:
Fit the trim caps, P/N 46 29 093, on the rear retaining bolt of the seat belts, beside the head restraints. See Figure 10 on following page.

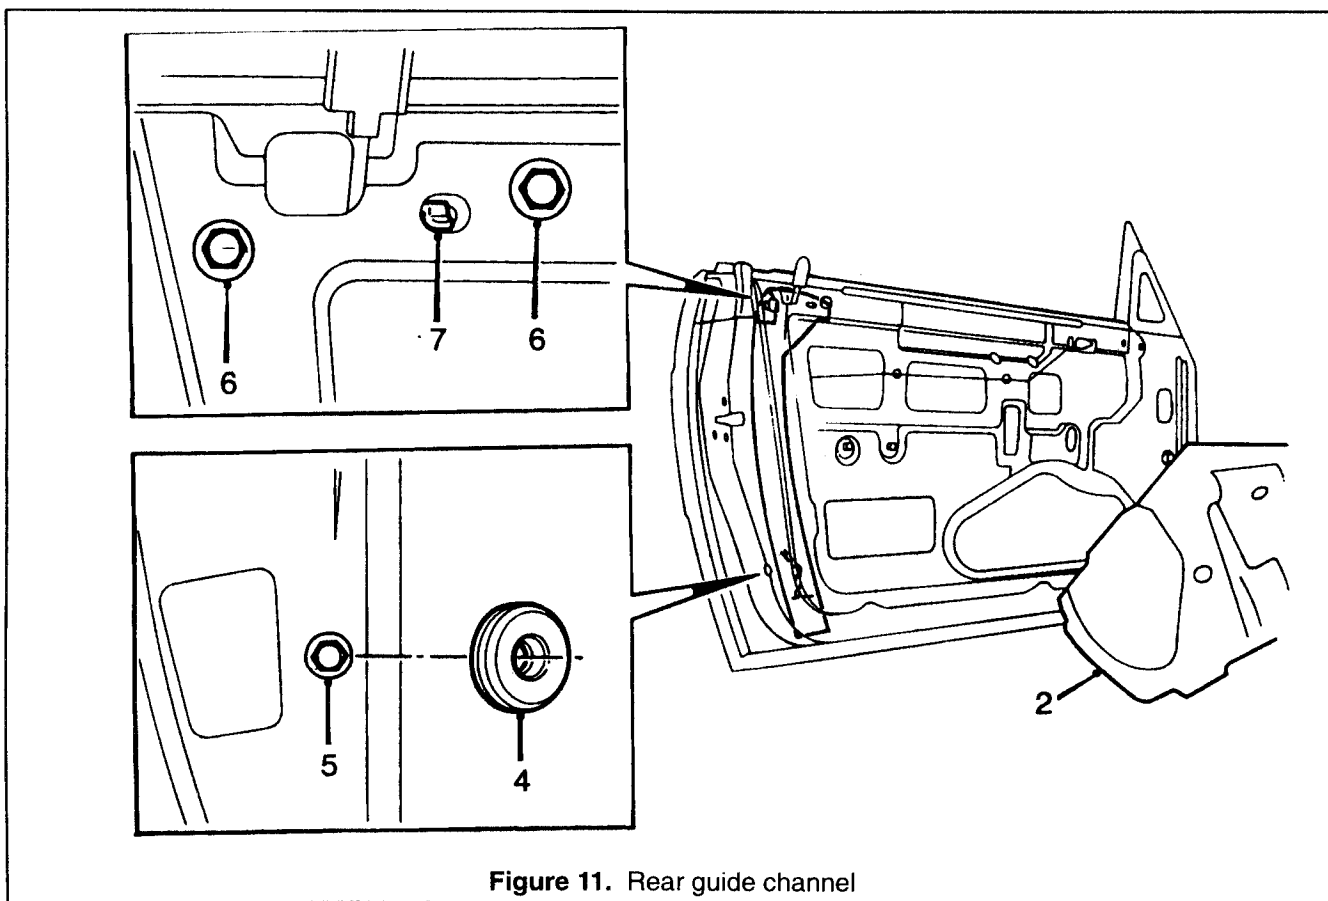
Figure 11. Rear guide channel

On certain cars there can be play between the rollers and the window track on the front door windows. As a result, a creaking noise is heard when the window is closed. The new rollers have a rubber o-ring that allows them to expand and contract, always filling the window track.

- Remove the door window rear guide channel and replace window rollers as follows:

1. Remove the door trim. See page 268 of Service Manual 8:5 Cabriolet.
2. Fold down the moisture barrier.
3. Raise the window fully.
4. Remove the rubber plug from the bottom of the trailing edge of the door.
5. Note the position of the rear guide channel adjusting screw by marking with a scribe on the bracket. Then, remove the channel.
6. Remove the screws securing the upper end of the guide channel.
7. Carefully push the glass outward and unhook the upper end of the guide channel from the door metal.

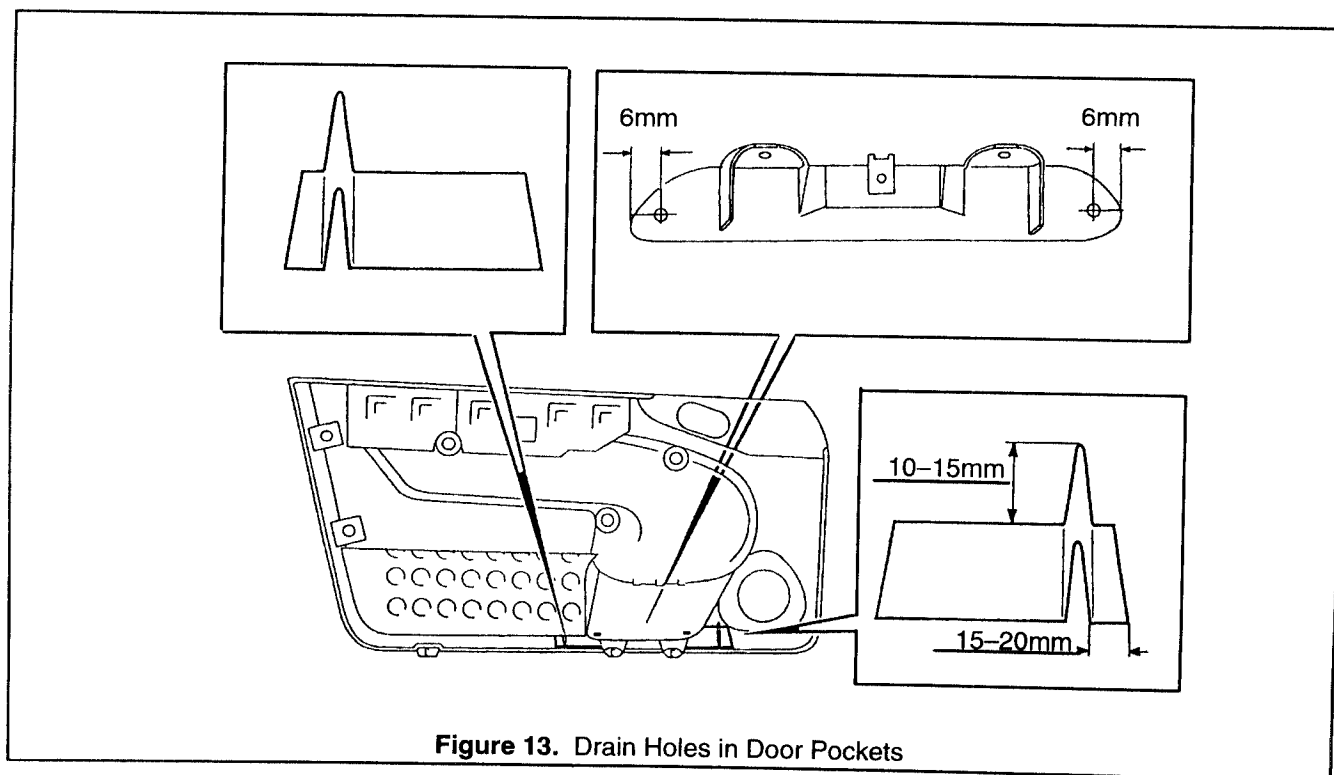
Customers may complain that the door pockets on their Convertible fill with water during a hard rain, when the vehicle is left parked in rain or if the windows are left slightly open. To rectify this complaint, drill drain holes in door pockets as indicated below.

1. Remove the door panel.
2. Undo the screw in the bottom of the door pocket. Pry out the pocket and mark the positions of the holes that are to be drilled. Use the mold joint as a center line. See Figure 13.
3. Drill holes where marked. Do not drill too deep as this could leave ugly marks in the pocket. Remove all plastic pieces from the pocket.
4. Fold the tape and place it as shown. The fold is to guide the water out through the hole in the seal and prevent water from running along to the front or rear of the door panel. See Figure 13.
