**SAAB****CAMPAIGN INSTRUCTIONS**

MI No. 811-1758	Date June 1997	
PI No. 5/97 Grupp 8 D 3.0	Distr. US

Customer Satisfaction Campaign 450: Replacement of Fifth Bow Latch Motor Assembly**Background**

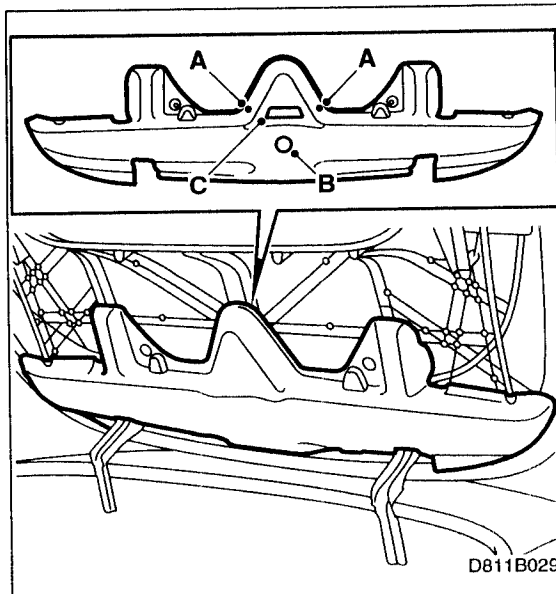
D811B029

First check whether the motor cover panel is fitted with two Torx screws(A) and that a plastic plug (B) and tape (C) are fitted to the cover panel. If the bolts or plastic plug are not fitted, proceed as described below.

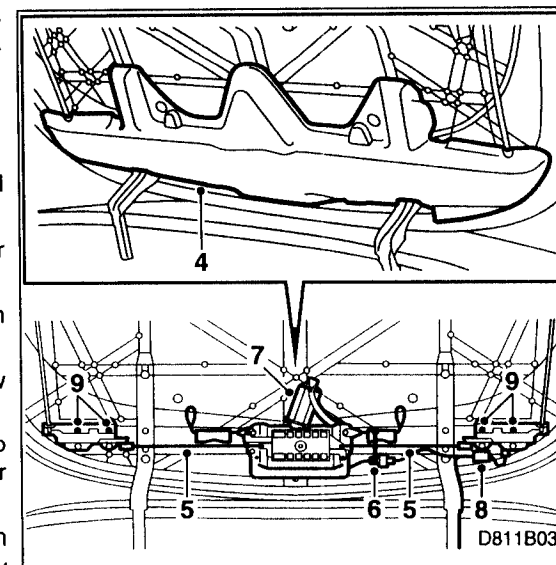
D811B031

Each locking mechanism is held together using two plastic shouldered pins, P/N 74 97 910 and four white plastic washers, P/N 74 97 928 (2 per pin).

The plastic pins may in some cases be broken from use or may be damaged upon removal. They should not be required to upgrade most cars if the original press/speed nuts are cut off as instructed.

The white plastic washers may be dropped and lost when disassembling the latch but do not normally fail or wear out.

New press/speed nuts to secure the latch assembly together come in each 5th bow latch motor upgrade kit, P/N 74 97 878.

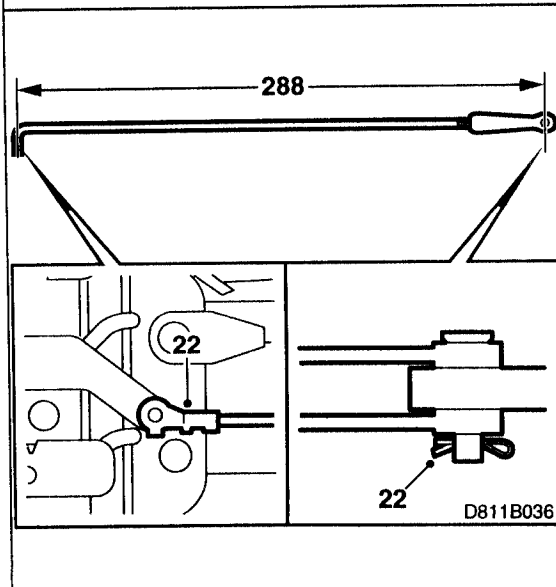
- 24 Check the locking tongue in the oval hole for the fifth bow lock. Max. 1.5 mm of the locking tab should be visible.

If the adjustment is incorrect and more than 1.5 mm of the locking tongue is visible, continue with points 25, 26 and 27. In most cases, no locking tongue will be visible through the opening.
