Saab 900 Convertible

Troubleshooting Guide:

Troubleshooting Information and
Service Information Bulletins

1995 - 900 Convertible

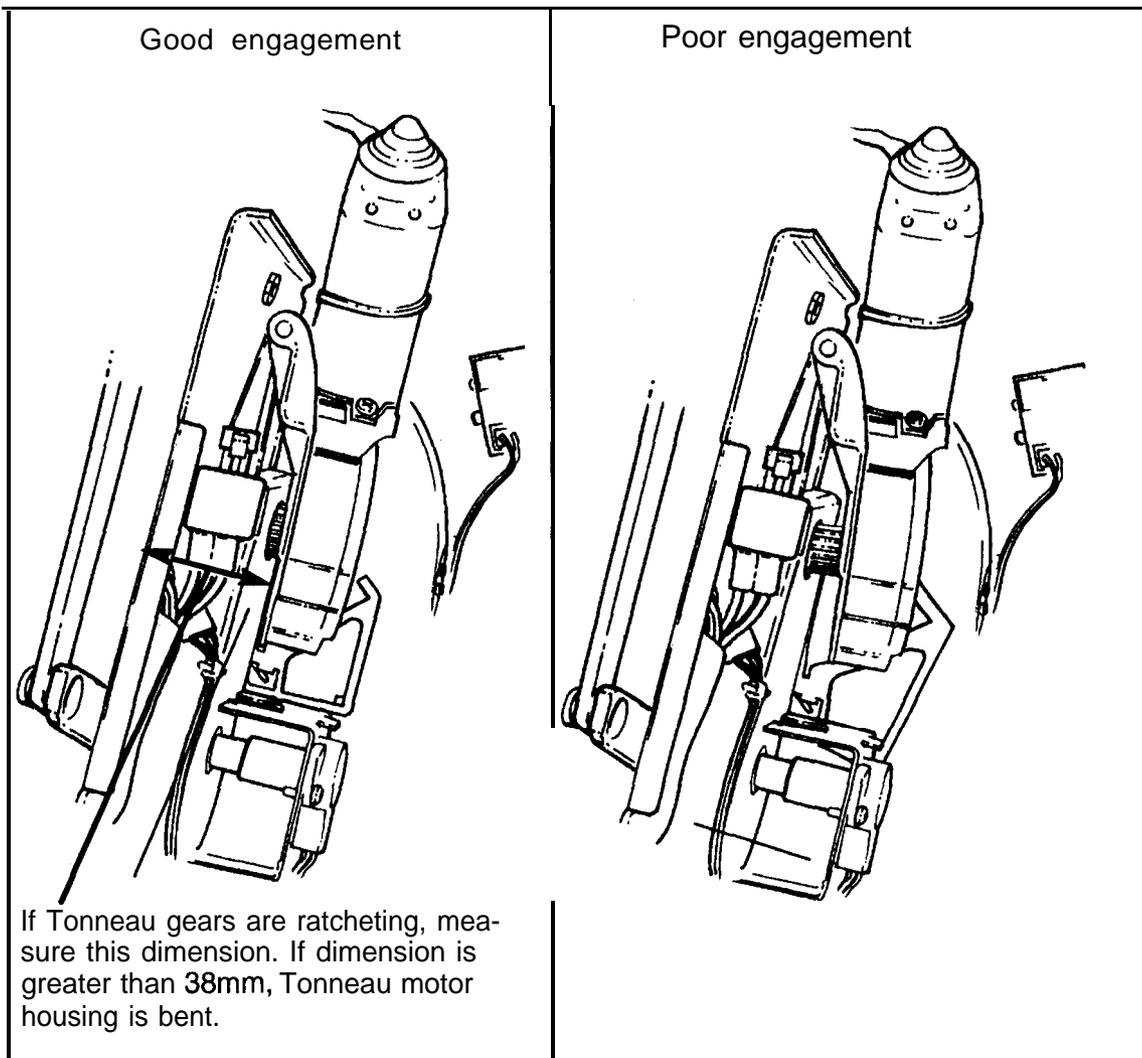
Remove the right taillight assembly to inspect the Tonneau motor. Check for proper engagement of Tonneau motor. If the dimension shown in the illustration is greater than 38mm and the Tonneau gears are making ratcheting noise, the Tonneau motor housing is bent. If there is insufficient engagement, check for gear damage and check emergency release handle cable adjustment (described on next page). If damage to gears or housing is visible, replace the Tonneau motor. See illustration below.

When the motor is properly engaged, note that the motor mounting plate is engaged in the slot and that the latch is parallel to the potentiometer bracket.

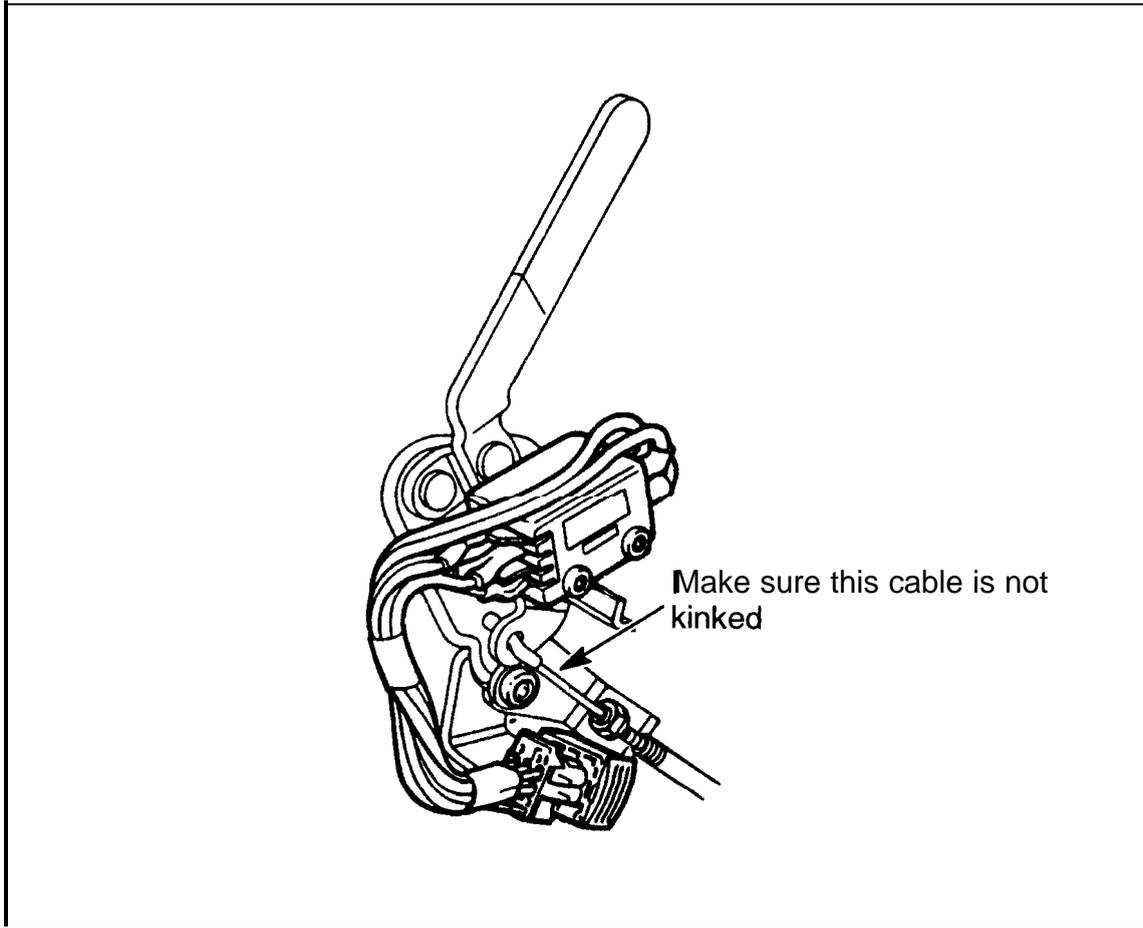
c. Tonneau motor disengaged? (continued)

There can be too much friction between the emergency release handle cable and the sheathing because of the way the sheathing/cable is positioned. Cut the ties securing the sheathing/cable to the body so that it finds a more natural position. Make sure that the release handle is pushed all the way to the rear of the car, and that the cable does not kink (see illustration). Resecure sheathing. Re-engage Tonneau motor, check cable adjustment.

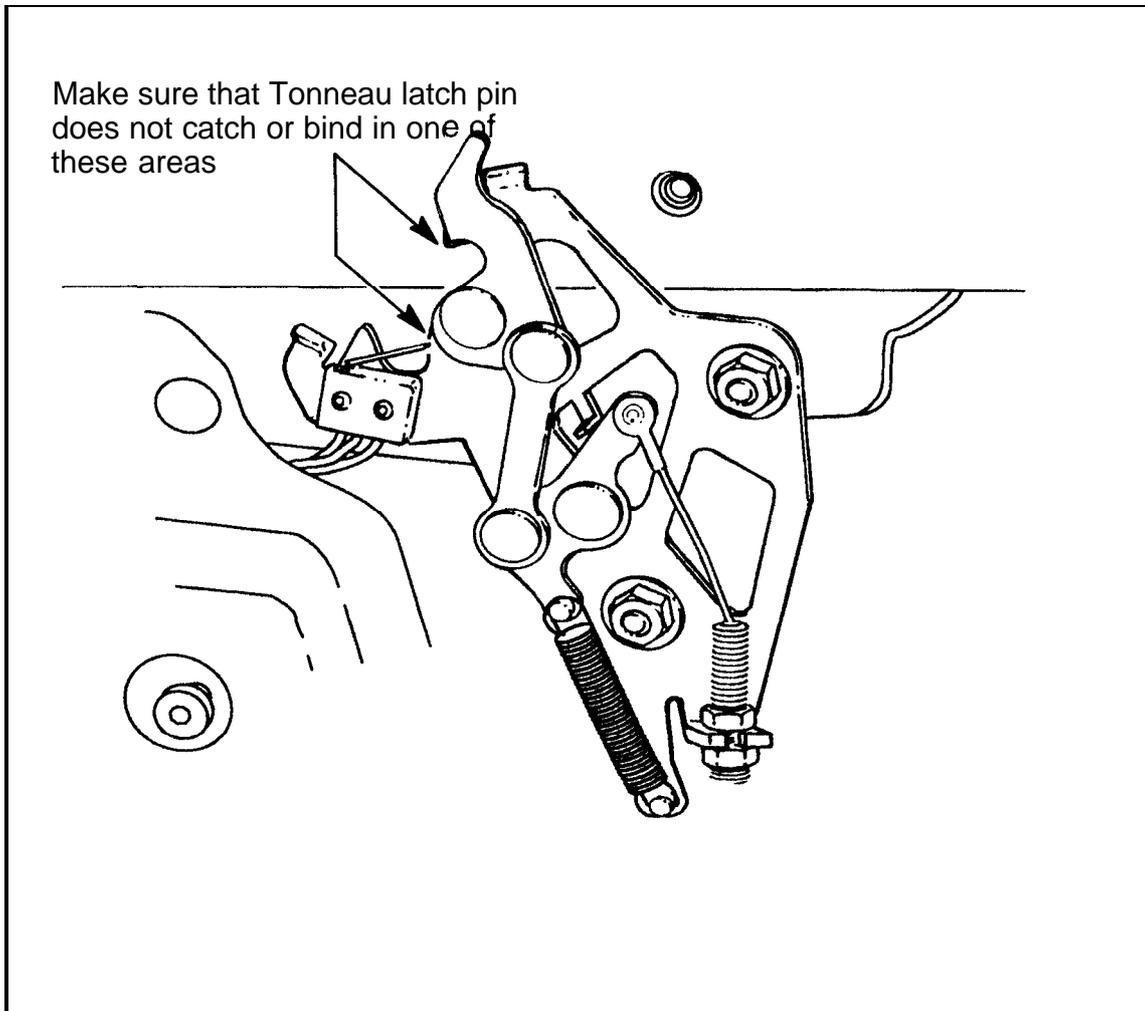
4. Tonneau cover catches going up – “snaps” when opening

Make sure to check the Tonneau cover latch adjustment with top fully raised, because the 5th bow pushes the Tonneau cover down when the top is fully raised.

Adjust striker and latch as per Service Manual 8:5 Cabriolet, pages 127-I 28.

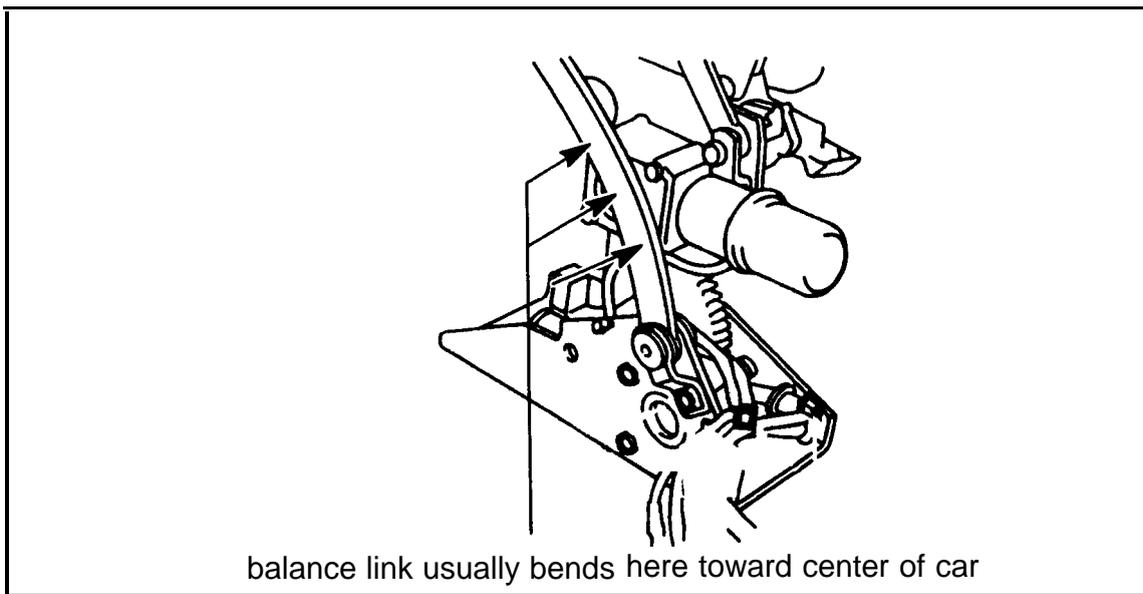
- a. Missing 2nd bow drive link or 2nd bow binding on fabric?

Perform Customer Satisfaction Campaign 428 if it has not been completed. This problem can occur if the 2nd bow does not flip back, causing it to contact the front side rails. This can bend the balance link. If slightly bent, it is OK to straighten it in the car. If balance links are severely bent, they are available as spare parts:

LH 47 67 398, RH 74 97 506

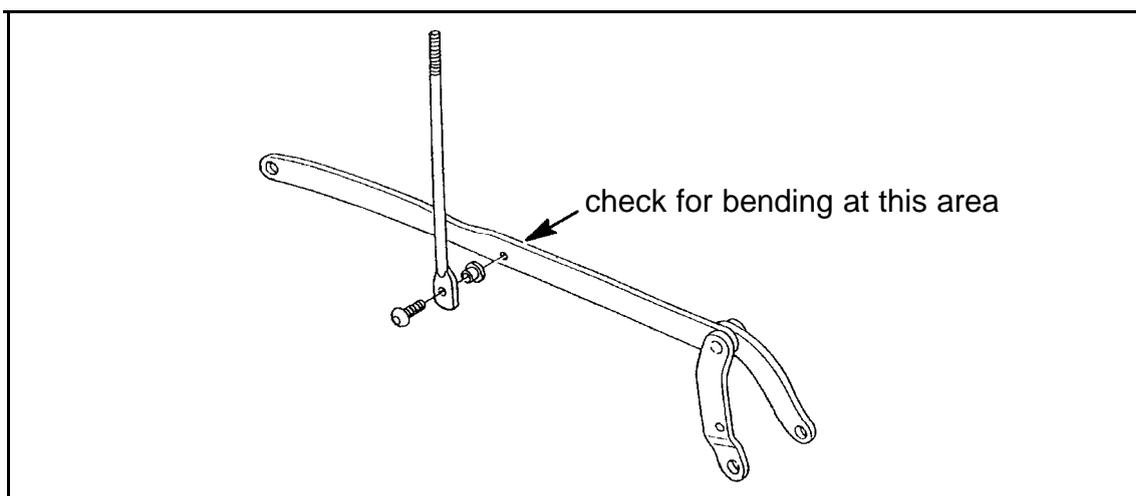
If the balance link is bent, also inspect the control arm on both sides for bending.

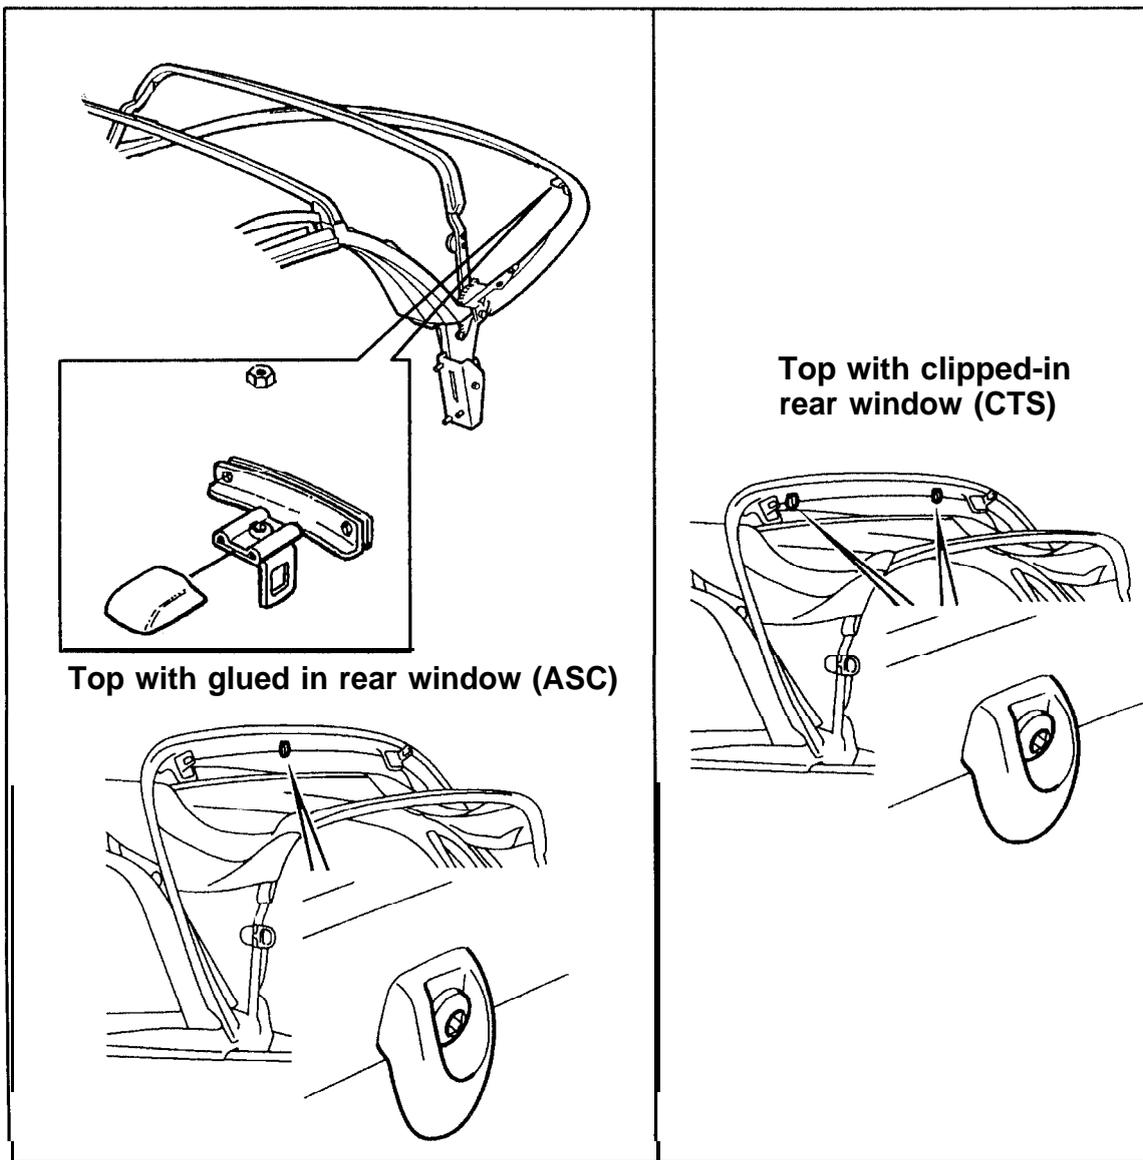
- Broken or missing stops on rear window?

If you are working on a Convertible which has none of these, install covers on 5th bow latches, P/N 45 59 431 LH, 45 59 456 RH.

See PSI 04/97-0753 Subject #9 for further details. Check to be sure that all of the steps in this PSI have been performed.

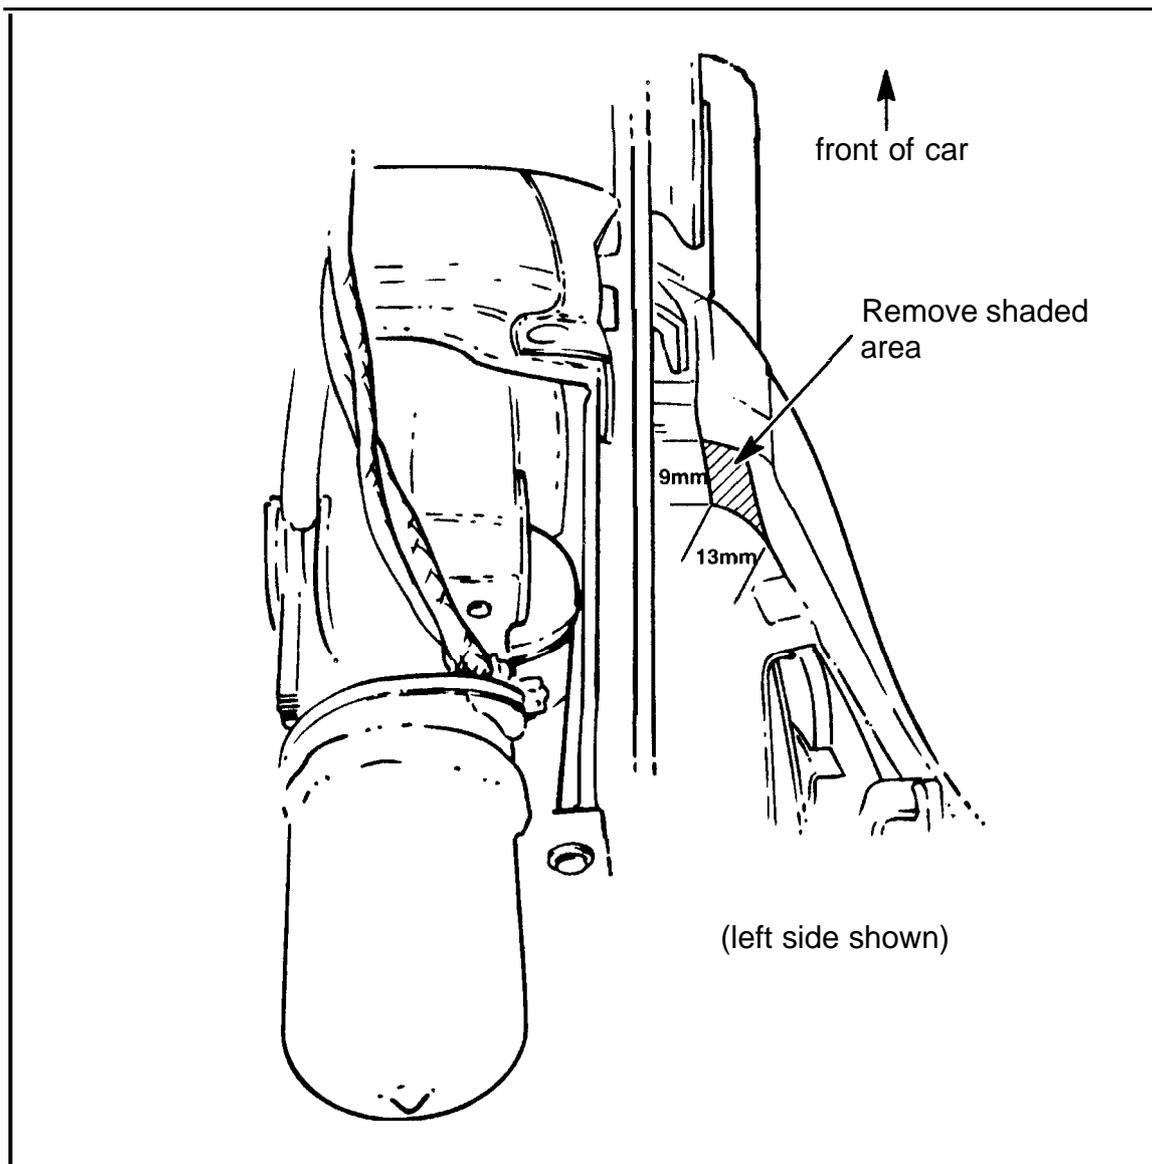
12. Top gets caught on interior trim panel on way down

- Early interior trim panel not cut at rear edge?
Cut panel – see illustration.

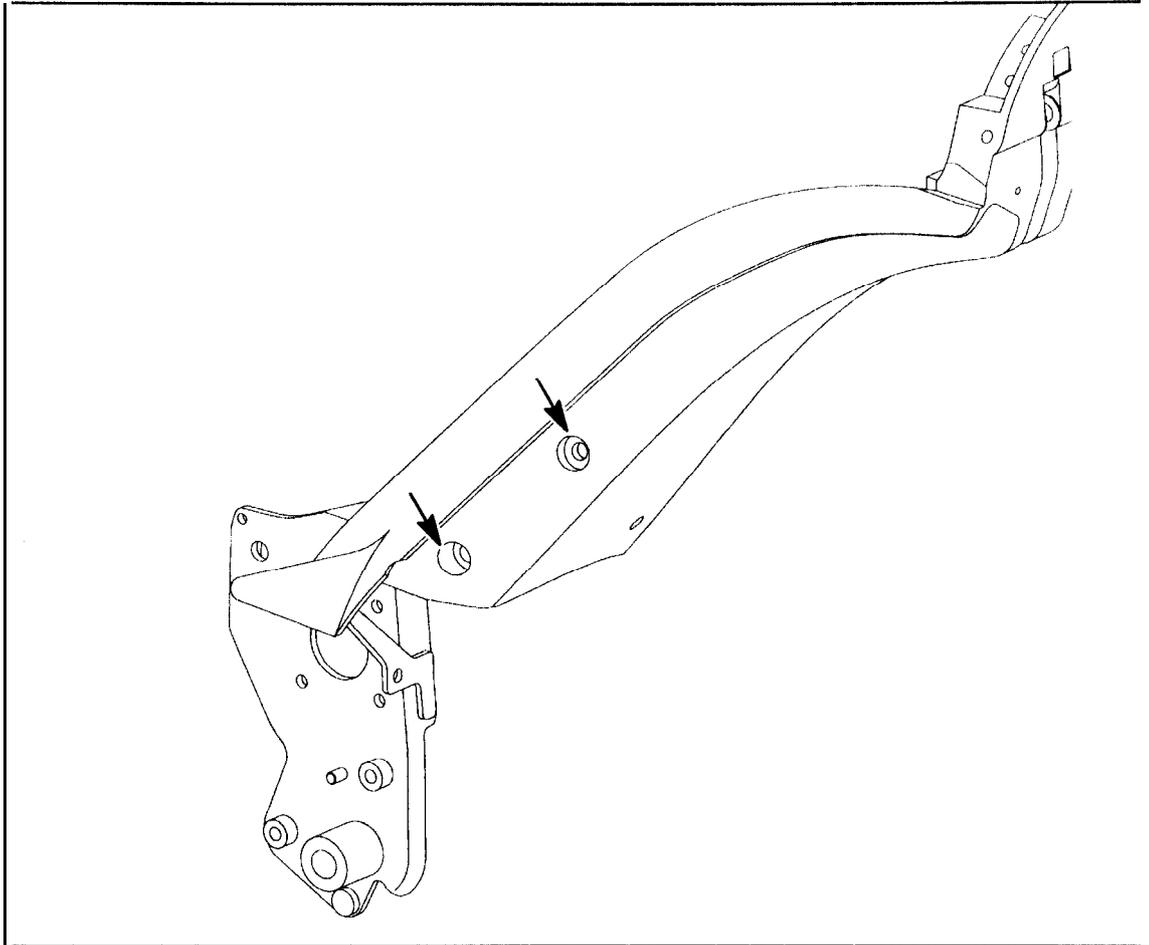
- b. Side rail screws loose?

Tighten screws as per Customer Satisfaction Campaign 428, item E, page 9 as well as the two noted in the illustration below.

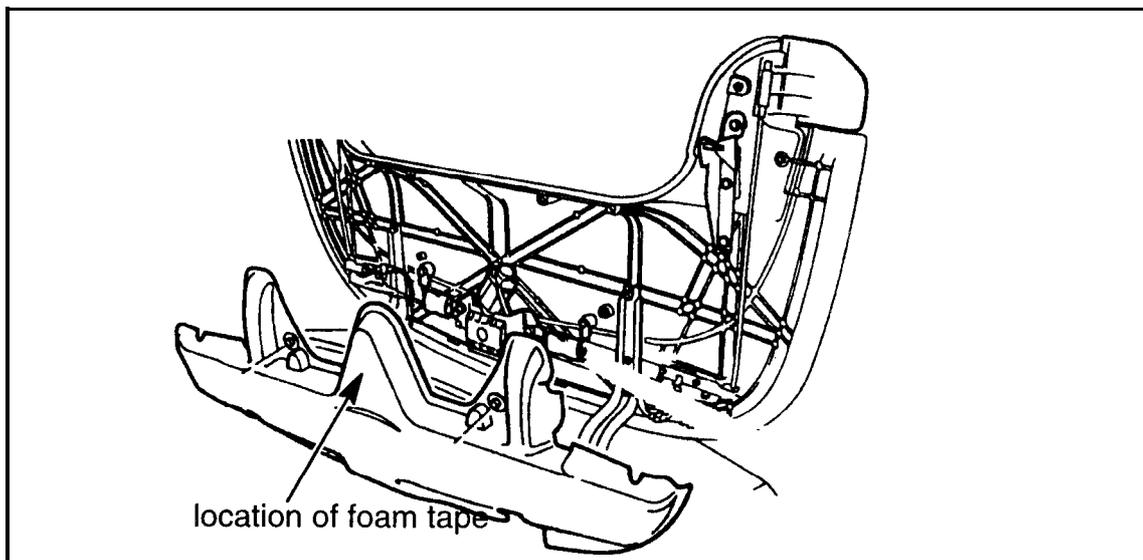
- When top is fully lowered, first bow rubs on 5th bow latch motor cover while driving

Install foam tape on underside of Tonneau cover. See illustration.

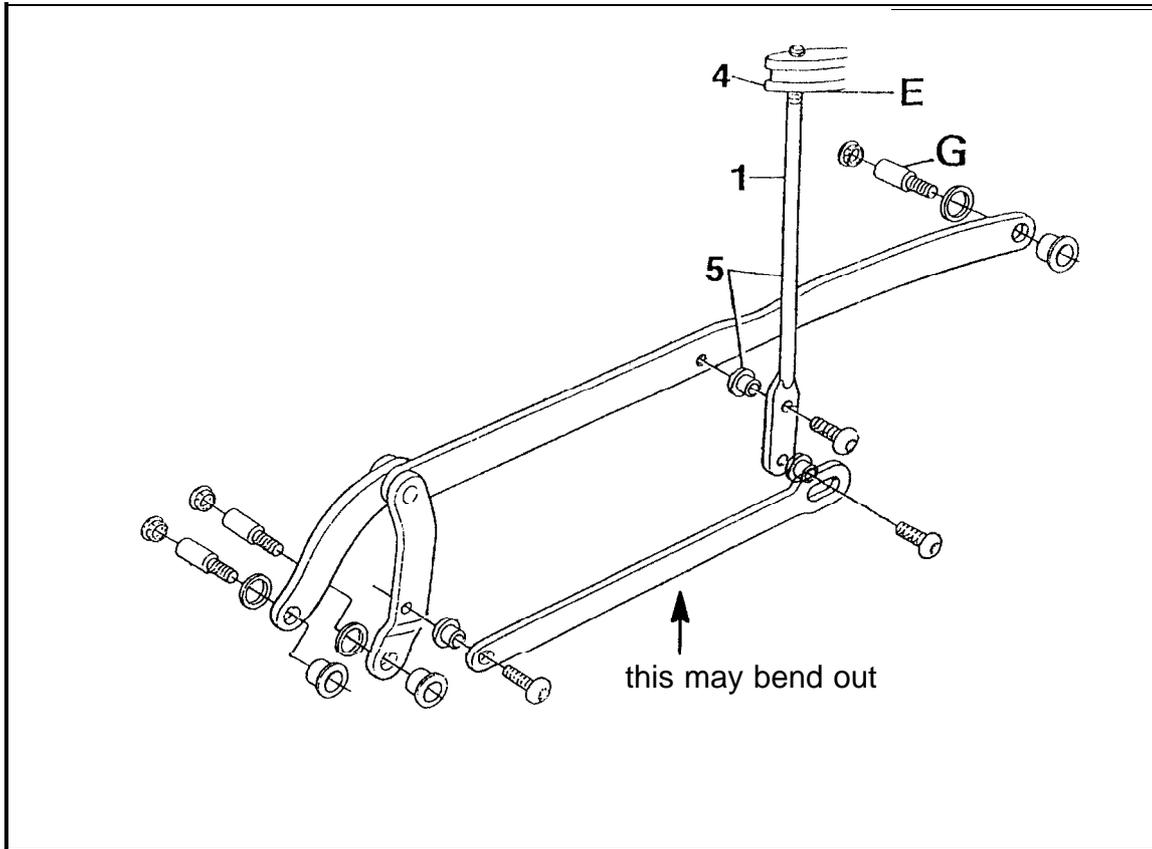
Open the top so that the front side rail is in a near vertical position. Note the angle of the 2nd bow flipper rod and compare it to the angle of the flipper rod on the other side of the car. If the bow is twisted, there will be an obvious difference in the angles of the rods.

Straighten or replace 2nd bow, and straighten or replace 2nd bow drive link.

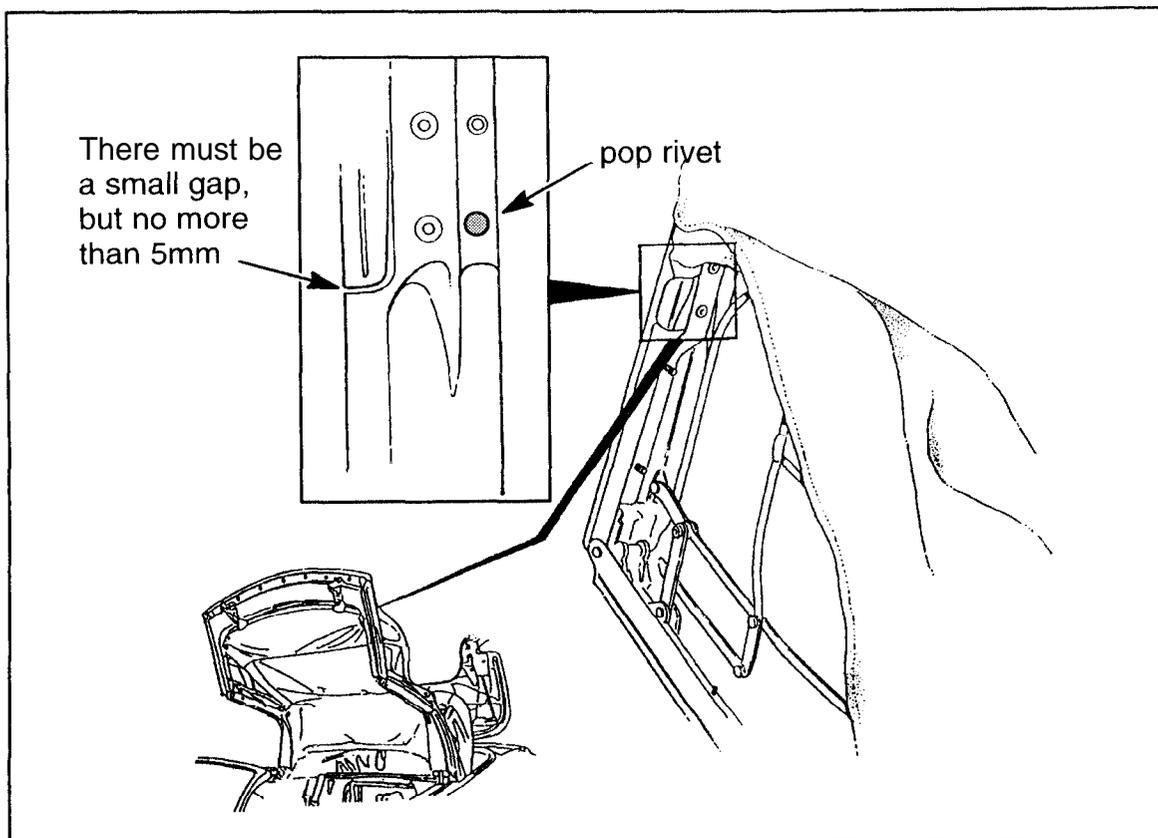
- Loose bolts at front side rail?

If these screws have been loose for some time, the pop rivet may have worked loose. Drill & reinstall a new pop rivet.

Tighten bolts as per Customer Satisfaction Campaign 428, item D, page 8.

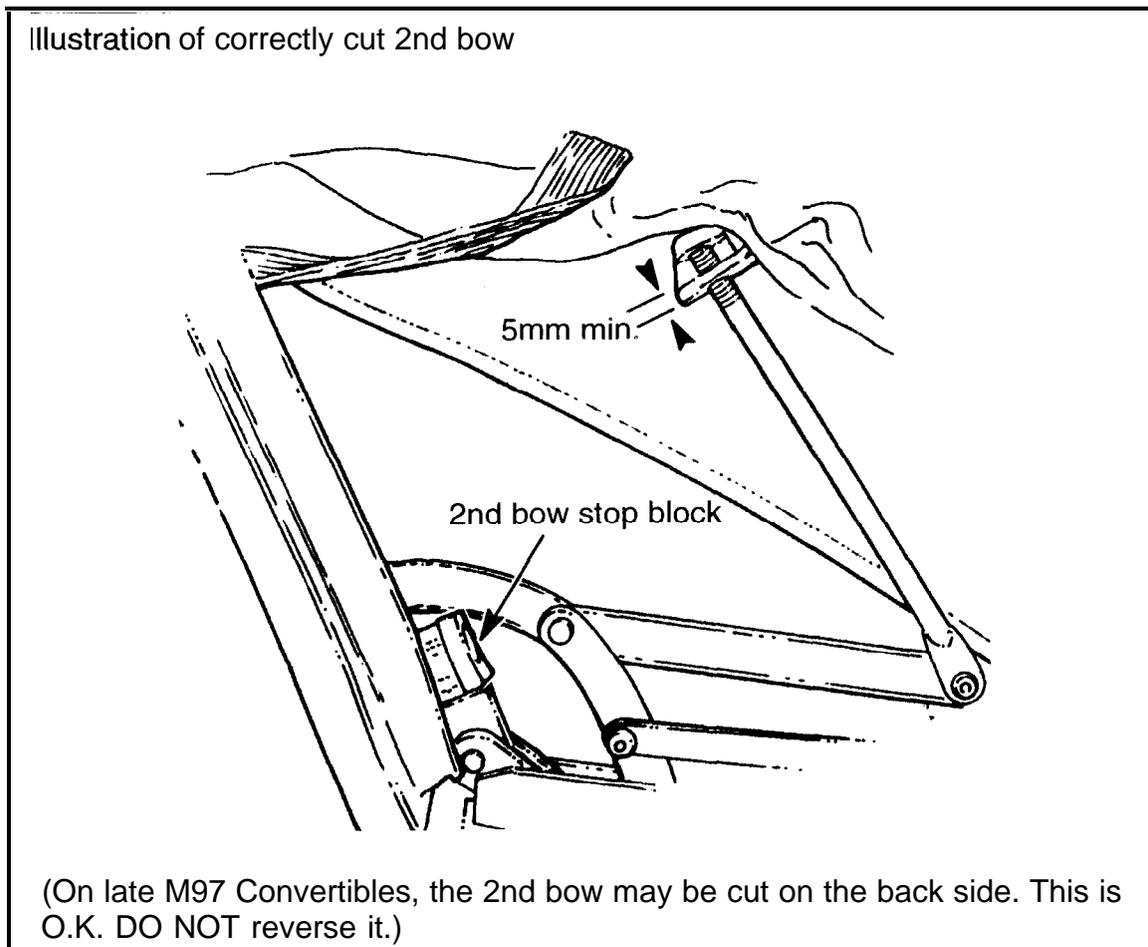
The end of the 2nd bow must have a flat surface at least 5mm wide which rests on the stop block when the top is fully raised. If there is less than 5mm, replace 2nd bow.

NOTE: If 2nd bow is not cut, DO NOT cut it.

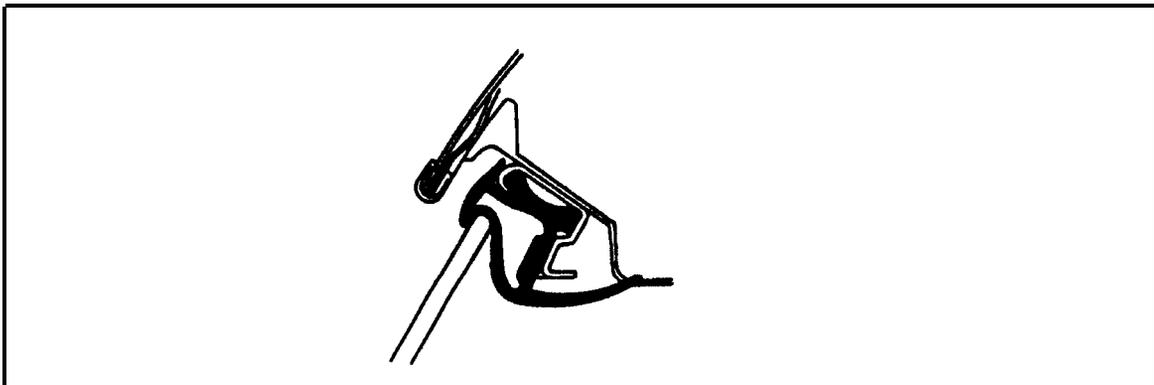
5. Side rail seal drooping

- Side rail seal not secured?

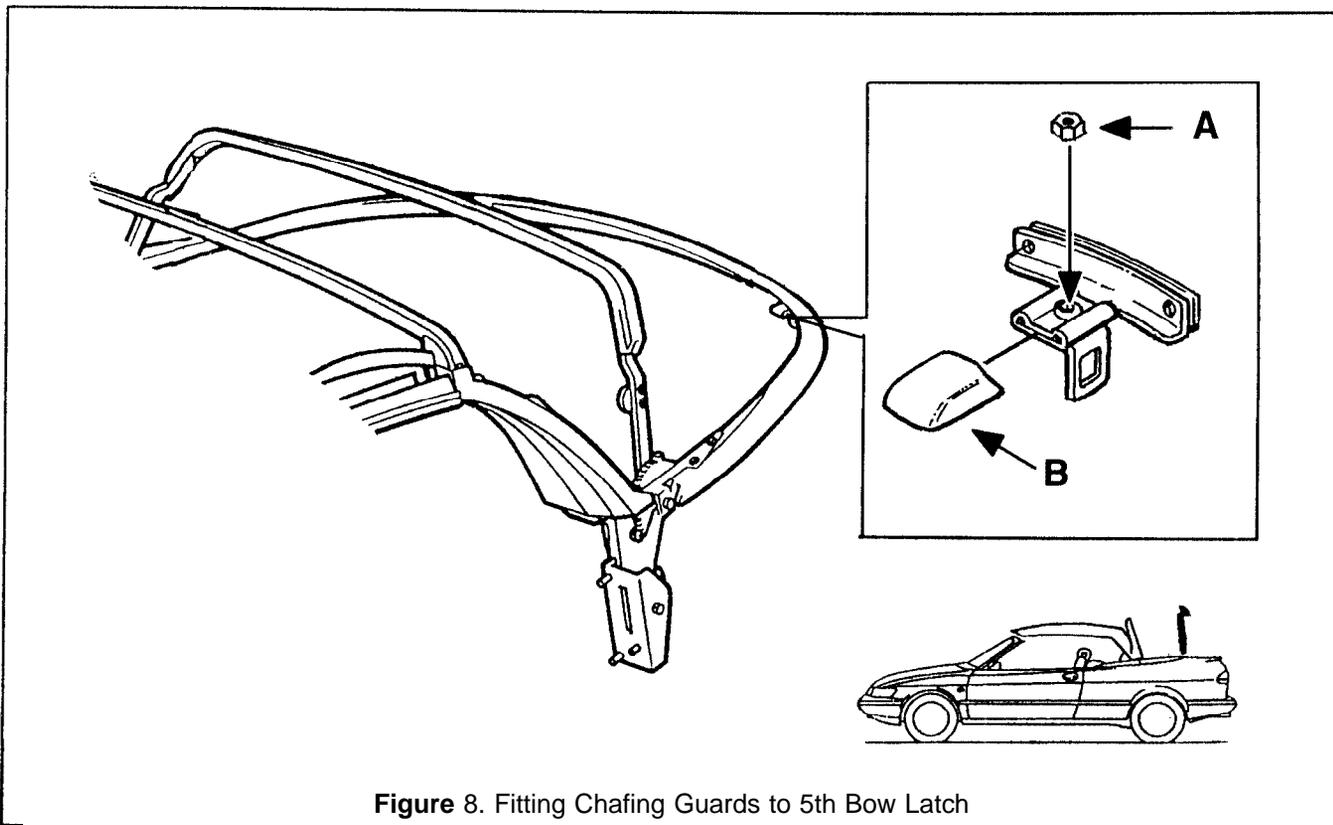
Figure 8. Fitting Chafing Guards to 5th Bow Latch

Fit chafing guards over the 5th bow's latch fittings to minimize the risk of wear on the top fabric when the top is down.

1. Operate the top using the "ROOF" switch until it is in the position shown above. The top, 5th bow and Tonneau cover should be fully raised.
2. A nut is welded to the top of the latch fitting. On a number of cars there is also an extra loose nut. Where fitted, this nut must be removed. See Figure 8.A..
3. Fit the chafing guard on the latch fitting. Make sure that the grooves in the guard fit on the edges of the latch bracket. See Figure 8.B.

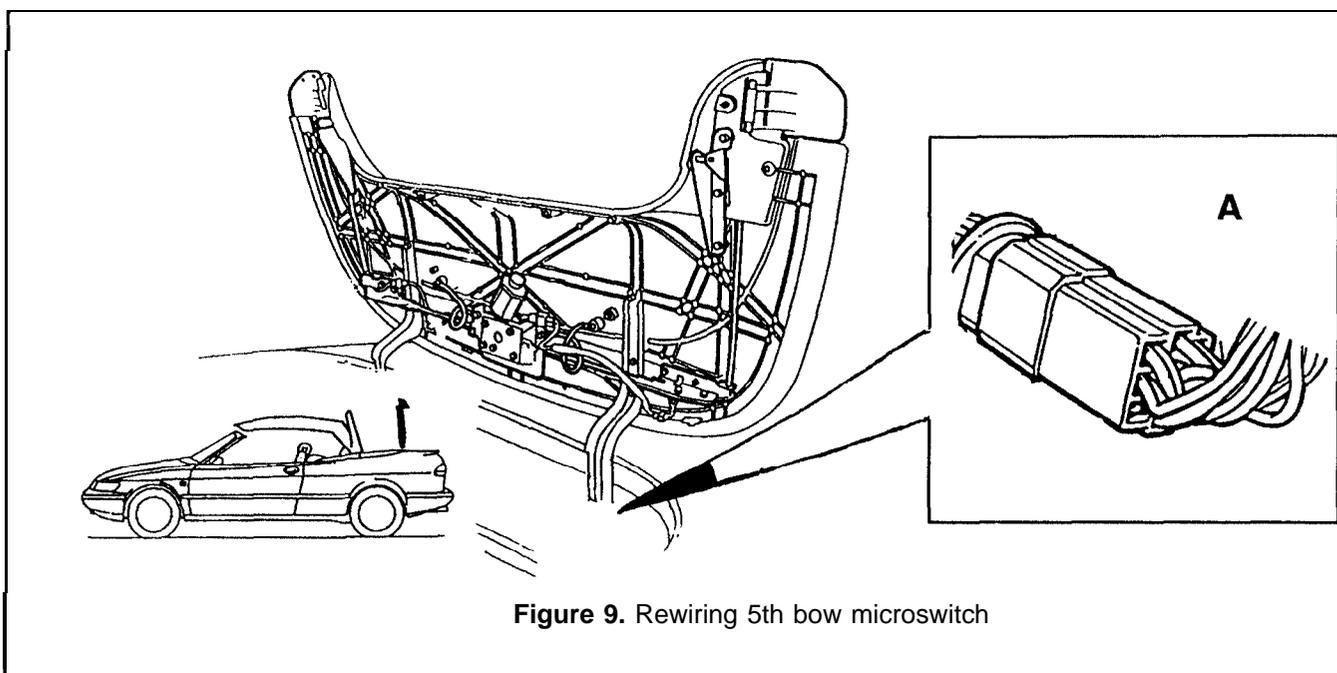
Figure 9. Rewiring 5th bow microswitch

NOTE: Some cars have had the wiring modified per instructions included herein but have not had the microswitch removed. If upon inspection you can determine that the wiring is correct, remove the microswitch and tape and secure the connector.

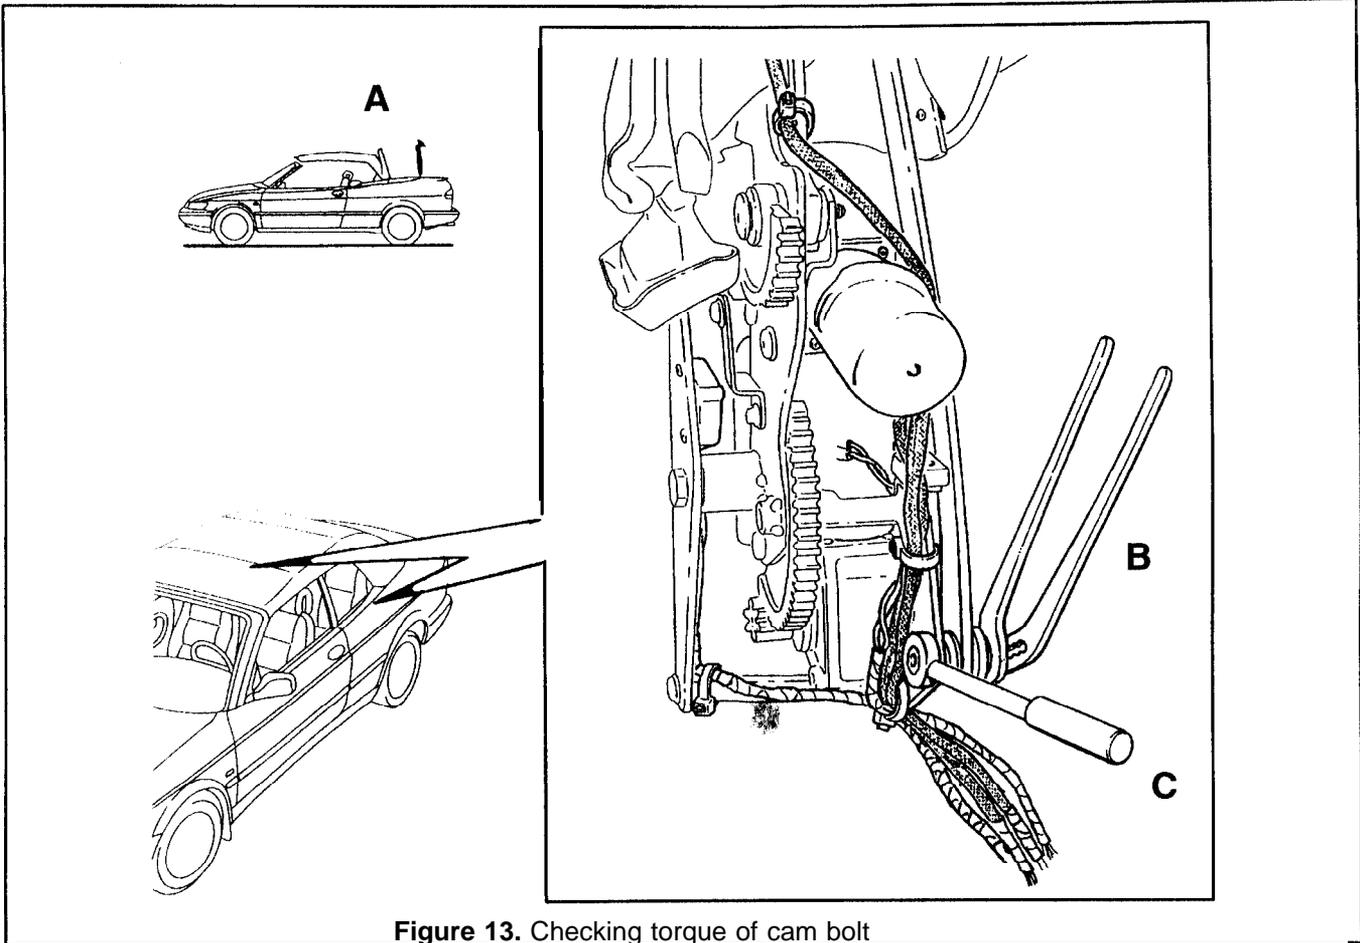
Subject #12: Controlling the movement of the balance link arm by checking torque of cam bolt
Application: VIN Serial Nos. S7000216-S7013982

Tighten cam bolts to 23Nm.

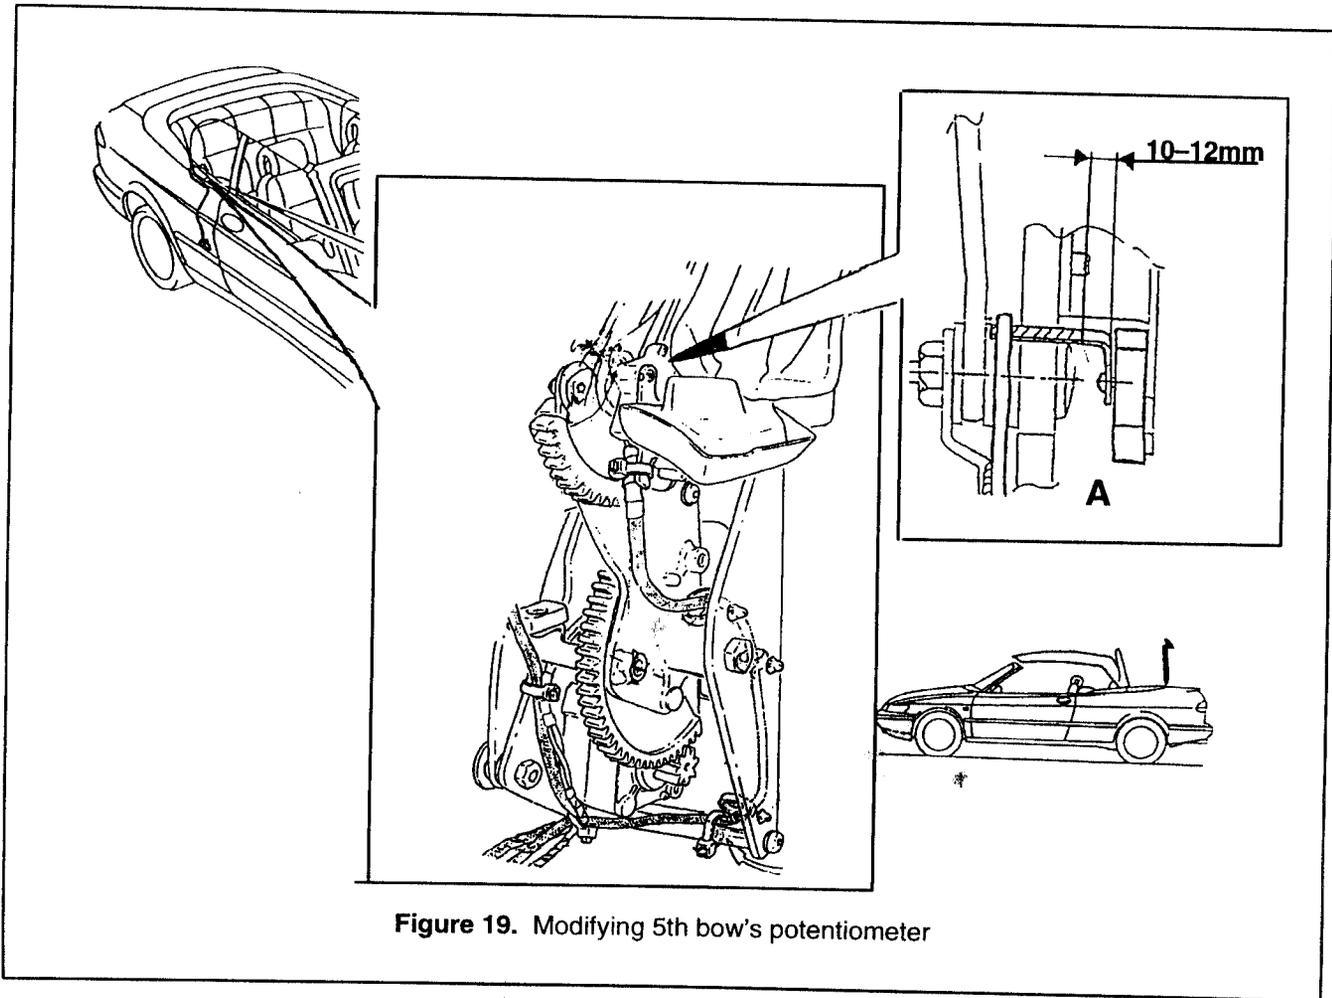
Figure 19. Modifying 5th bow's potentiometer

These cars must have the 5th bow's potentiometer modified as follows:

- a. Select "5TH BOW LATCH MOTOR, UP" in the "ACTIVATE" menu to open the fifth bow's latches.
- b. Select "5TH BOW MOTOR, UP" in the "ACTIVATE" menu and run the 5th bow to the fully raised position.
- c. Select "TONNEAU MOTOR, UP" in the "ACTIVATE" menu and run the Tonneau cover to the fully raised position.
- d. Hold the 5th bow's potentiometer arm steady and carefully cut it off as shown in Figure 19 below. Use a sharp pair of side cutters. See Figure 19.A.
- e. Apply primer to the cut surface as corrosion protection.
- f. Program Convertible top per PSI 04/97-0758.
