# Parts & Service Information

Subject: Addressing Complaint of Water

**Leaks from Area Around Door Mirror**

CATEGORY Body	
SECTION 8	PAGE 155
04/97-0760	CODE 811

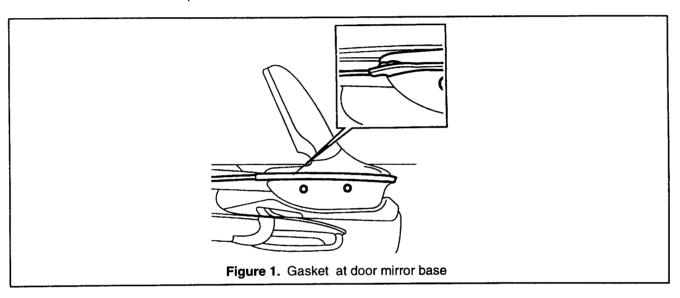
Should a customer complain that they have a water leak in the area around the door mirror on their 1995 or later 900 Convertible, a new gasket for the door mirror base can be installed. This new gasket has better sealing properties and was introduced on current production models.

Raise the car and check whether the gasket and window form an unbroken line.

If they do not, the front edge must be bent upward slightly when the door mirror has been removed.
