Subject: Addressing Customer Complaints of Water Leaks

Application: 1995 900 Convertible

CATEGORY	
Body	
SECTION	PAGE
8	150
ISSUE	CODE
04/97-0755	812

Supersedes PSI 02/96-0665

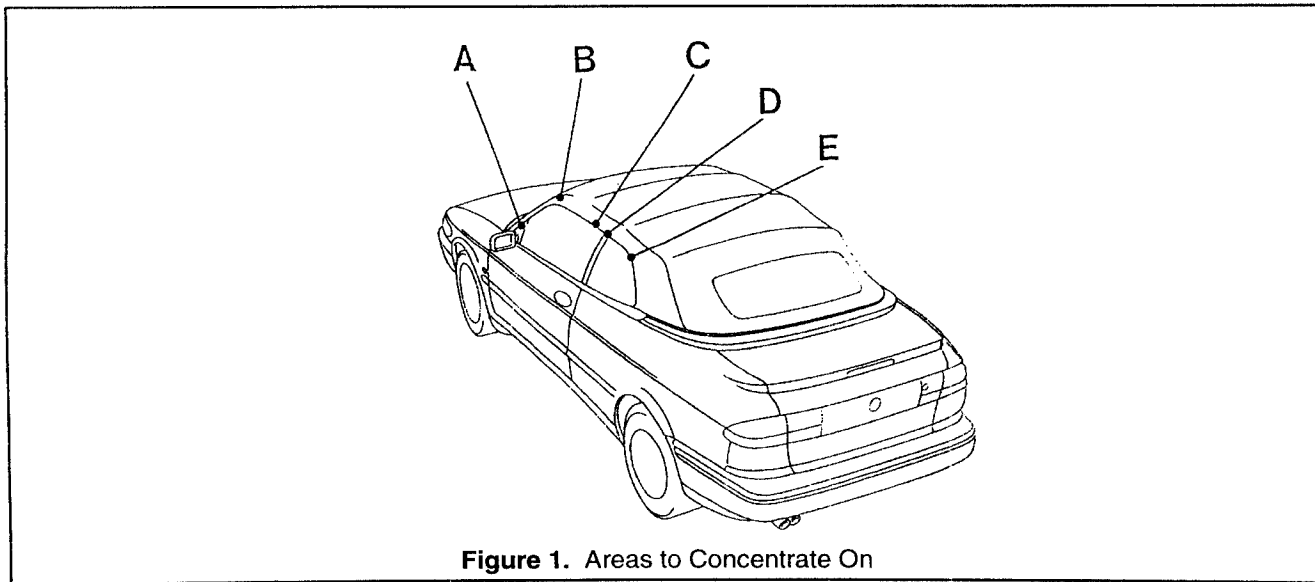
Figure 1. Areas to Concentrate On

Areas of Potential Leaks:

- A. Leakage from the Door Mirror Mounting Flange
- B. Leakage at the joint between the Header Seal and the Front Side Rail Seal
- C. Leakage at the joint between the Front and Center Side Rail Seals
- D. Leakage where the Upper Edge of the Rear Window Seal meets the Center Side Rail Seal
- E. Leakage between the Rear Edge of the Center Side Rail Seal and the Rear Side Seal

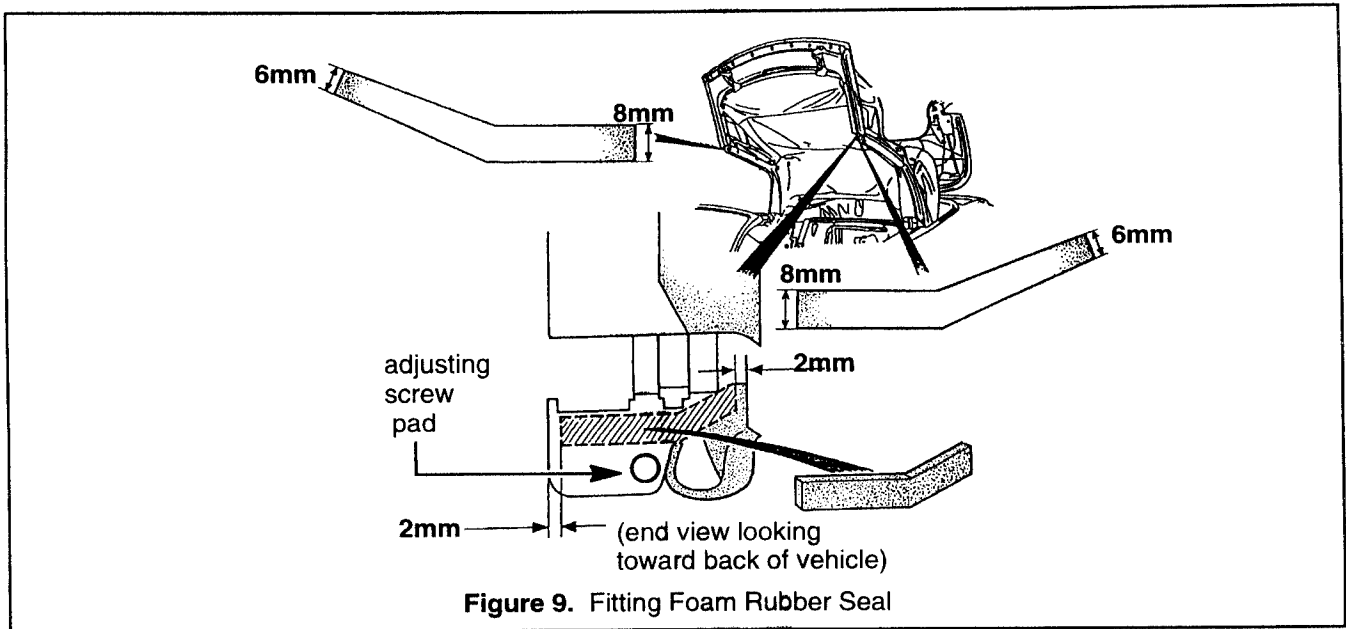
If water leaks in between front and center side rails from above the seal, fit a foam rubber seal between the front and center side rails as follows:

Cut the foam rubber seal to the shape as shown in Figure 9. Make sure that the foam rubber seal does not cover the adjusting screw pad.

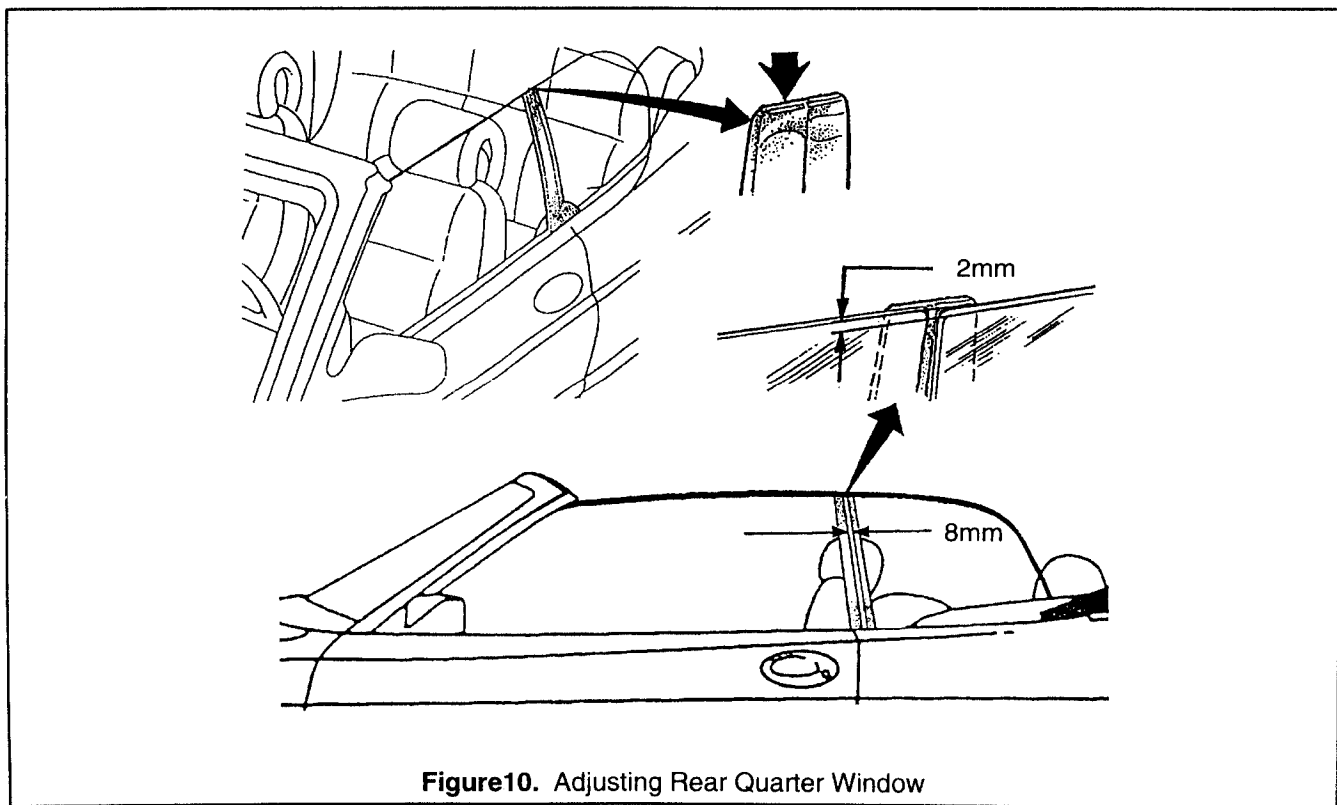
Figure10. Adjusting Rear Quarter Window

- D. LEAKAGE WHERE THE UPPER EDGE OF THE REAR WINDOW SEAL MEETS THE CENTER SIDE RAIL SEAL**
- E. LEAKAGE BETWEEN THE REAR EDGE OF THE CENTER SIDE RAIL SEAL AND THE REAR SIDE RAIL**

1. Adjust the rear quarter window. See Service Manual 8:5, page 136. It should be 1–2mm below the top of the front side window.
The clearance between the front side window and the leading edge of the rear quarter window should be 5/16" (8mm) from top to bottom. See Figure 10.
2. Adjust the front seal and center side seals outward. See page 137 in Service Manual 8:5.

Do not move the seals out so far that the front side window is pressed outward. The front side window must be in contact with the seal on the rear quarter window.
