9-5 A/C BLEND DOOR REPAIR

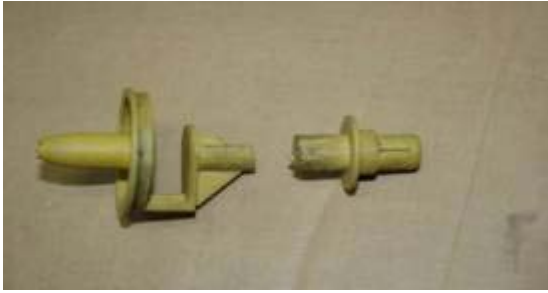
The shaft that connects the stepper motor to the blend door fails as shown above.

Reinstall “elbow”, and stepper motor. Replace any covers removed. NOTE: Be aware that the green bushing in the picture at the top of the page also fails. It is part number 4869244. The replacement is white. SEE Service Bulletin 854-2461 for details.

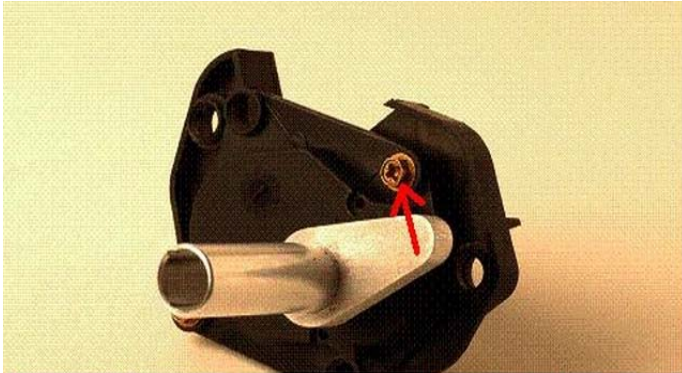
to aid in reassembly, preposition servo using repair part as a tool, so the stop arm covers this screw.

The original repair part, manufactured from aluminum, is shown attached to the servo above. Currently we are shipping a molded part made of aluminum and plastic as it significantly reduced assembly time for us. **To facilitate reassembly, it is a good idea to index the stepper motor.** We suggest you use the repair piece as a tool to rotate the stepper motor shaft. Refer to the picture above. **You will want to position the stop arm over the screw that is shown just to the left of the stop arm in the picture.** Be aware that it takes quite a bit of torque to get the stepper motor to start turning, but once it starts to move, it goes easier.

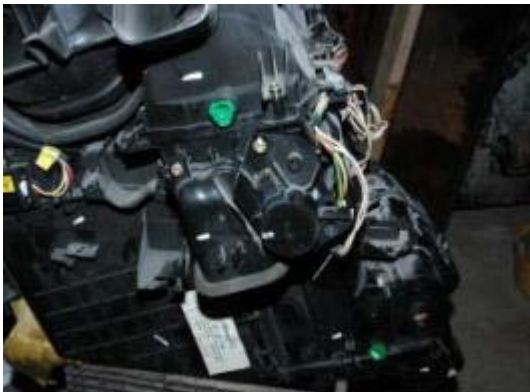
Without the new process 10 to 15 hours of labor is required to remove and replace the heater box.

The new process can be completed in the vehicle in approximately 1 hour. First one must gain access to the

stepper motor by removing the lower dash cover on the driver's side, or glove box on the passenger side. The process shown is for the left side. Remove the servomotor, temp sensor, and vent "elbow". Next remove the "stop lever" by pressing down slightly on the lock tab and pulling it straight off. If the stop lever is missing don't worry about it, as it is integral to the new repair part.

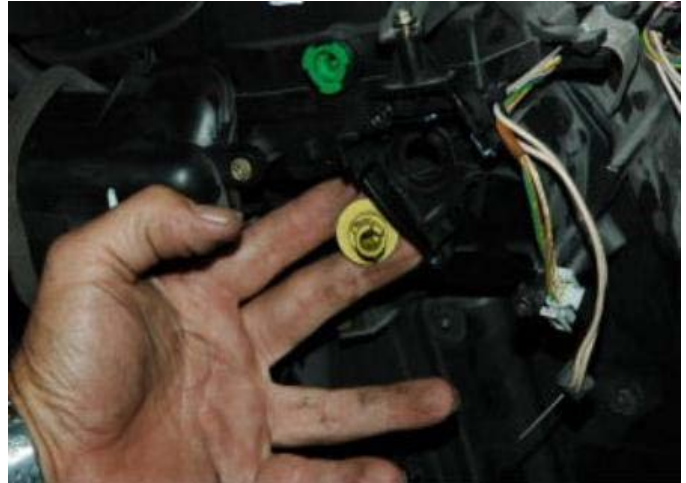
Reach inside the case, removing the broken shaft from within. This is not easy, repositioning blend door may help, and you will have to press pretty hard sometimes. Another option is to use a hacksaw blade to cut off the servo end of the yellow shaft, so it does not need to go so far into the case to clear. **IF THE SHAFT IS NOT BROKEN**, remove the stop arm from our part and install it on the blend door shaft. **DO NOT** cut the shaft. Replacing the stop arm with our aluminum one will permanently repair the vehicle.

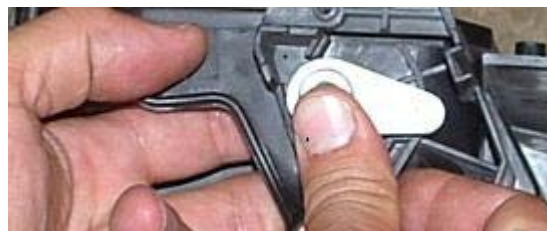
If you have not done so already, "clock the servo motor" by following the directions at the second picture above. Then insert the **REPAIR PIECE IN THE SAME FASHION AS SHOWN HERE**, supporting the bellcrank area of the blend door shaft with your left hand. Rotating the yellow blend door shaft clockwise, may help, and sometimes holding it in place with a pick helps when attempting to index the parts.

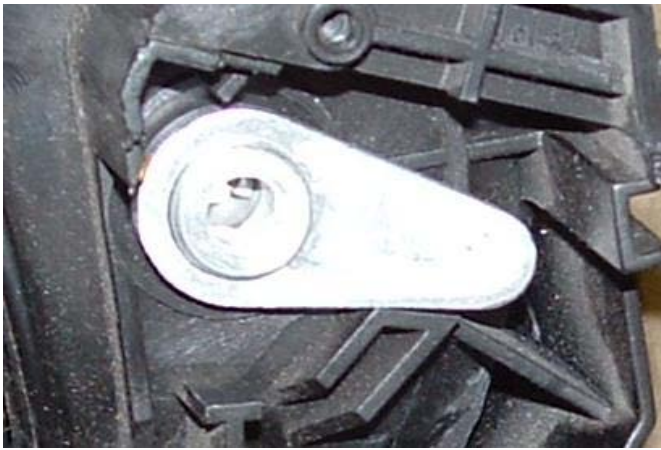
Then, While supporting the other part of the broken shaft from within the case, press the two parts together.

Clear the codes in the ACC system using the Tech 2 tool and recalibrate the system. If you do not have a Tech 2 just recalibrate by pressing auto and off simultaneously. Make sure the recirculate door operates correctly and that the system is full of refrigerant, because your customer has no idea how many different ways the air conditioner can fail. **The link arm for the recirculate door breaks on occasion, and often the gears in the servomotor fail as well. The link arm part number is 4869426.**

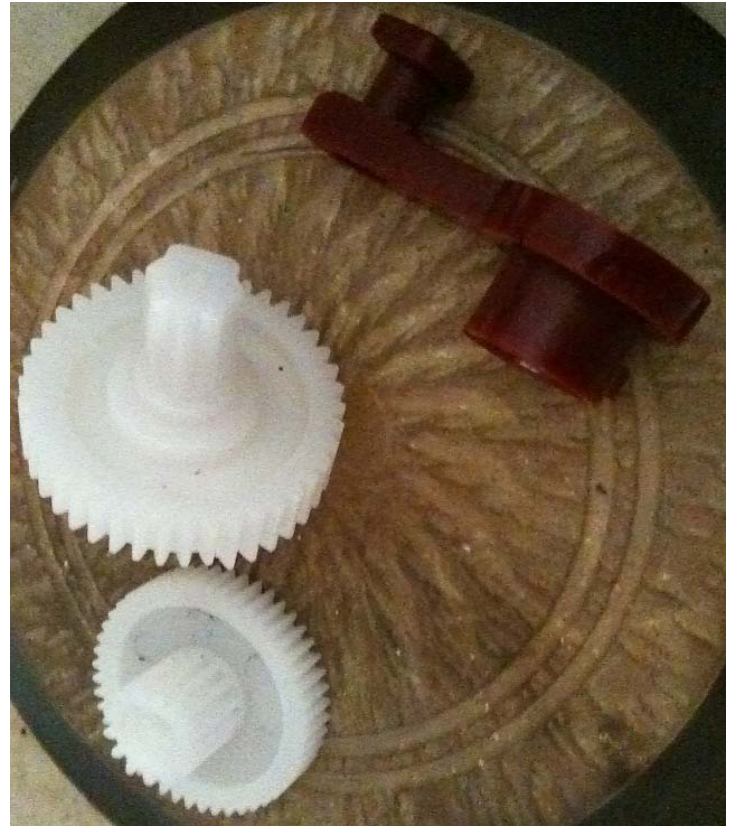
We are pleased to announce the availability of a repair kit for the recirculate servo motor.

It includes the 2 gears that often break, as well as the link arm mentioned earlier. The items are shown in the picture below.
